# Access Compliance Report

## Public Rights-of-Way

### (Island Curb Cuts)

Intersection ID: 21454	Main Street: SARDIS_RD_NORTH	Cross Street: MAPLE_SHADE_LN	Location: E
ADA ID: 7179CCC6D48B	Curb Cut Type: MedianRefuge2	Initial Pass/Fail: Fail	Overall Compliance: No
Codes/Mitigation Info/Possible Solution		Field Measurements/Component Compliance	
Severity Score: 0

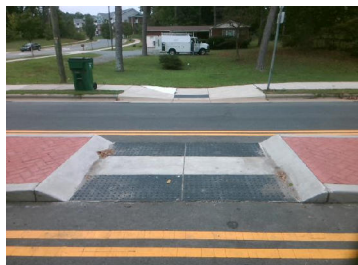
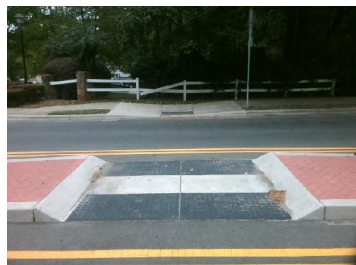
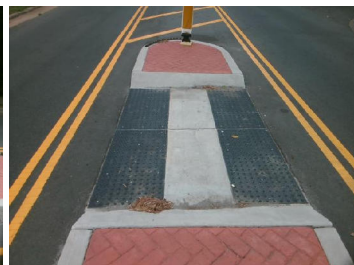
Compliance	Description	Data	Compliance	Description	Data
No	Refuge 1 Length (In)	35.5	N/A	Gutter 1 Ponding?	N/A
Yes	Refuge 1 Width (In)	98.0	N/A	Gutter 1 Lip Ht (In)	N/A
Yes	Refuge 1 Slope (%)	0.2	N/A	Gutter 1 Slope (%)	N/A
Yes	Refuge 1 X Slope (%)	0.9	N/A	Gutter 1 X Slope (%)	N/A
N/A	Painted X Walk1?	No	N/A	DWS 1 Provided?	N/A
N/A	X Walk 1 Direction	To S	N/A	DWS 1 Contrast?	N/A
N/A	X Walk 1 Width (In)	N/A	N/A	DWS 1 Length (In)	N/A
N/A	Road 1 Slope (%)	1.0	N/A	DWS 1 Full Width?	N/A
N/A	Road 1 X Slope (%)	2.6	N/A	DWS 1 Offset (In)	N/A
No	Refuge 2 Length (In)	35.5	N/A	Gutter 2 Ponding?	N/A
Yes	Refuge 2 Width (In)	98.0	N/A	Gutter 2 Lip Ht (In)	N/A
Yes	Refuge 2 Slope (%)	1.1	N/A	Gutter 2 Slope (%)	N/A
Yes	Refuge 2 X Slope (%)	2.5	N/A	Gutter 2 X Slope (%)	N/A
N/A	Painted X Walk2?	No	N/A	DWS 2 Provided?	N/A
N/A	X Walk 2 Direction	To N	N/A	DWS 2 Contrast?	N/A
N/A	X Walk 2 Width (In)	N/A	N/A	DWS 2 Length (In)	N/A

N/A	Road 2 Slope (%)	1.5	N/A	DWS 2 Full Width?	N/A
N/A	Road 2 X Slope (%)	5.3	N/A	DWS 2 Offset (In)	N/A
N/A	Refuge 3 Length (in)	N/A	N/A	Gutter 3 Ponding?	N/A
N/A	Refuge 3 Width (in)	N/A	N/A	Gutter 3 Lip Ht (in)	N/A
N/A	Refuge 3 Slope (%)	N/A	N/A	Gutter 3 Slope (%)	N/A
N/A	Refuge 3 XSlope (%)	N/A	N/A	Gutter 3 XSlope (%)	N/A
N/A	Painted X Walk3?	N/A	N/A	DWS 3 Provided?	N/A
N/A	X Walk 3 Direction	N/A	N/A	DWS 3 Contrast?	N/A
N/A	X Walk 3 Width (in)	N/A	N/A	DWS 3 Length (in)	N/A
N/A	Road 3 Slope (%)	N/A	N/A	DWS 3 Full Width?	N/A
N/A	Road 3 XSlope (%)	N/A	N/A	DWS 3 Offset (in)	N/A
Yes	Any Obstructions?	N/A	N/A	Storm Grate/Utility Hazard?	N/A
N/A	Obstruction Type		N/A	Storm Grate/Utility Type	
		N/A			N/A
N/A	Surface Condition	Good

**Remove & Replace Entire Refuge.**

**\$ 3000.00**
