# Access Compliance Report

## Public Rights-of-Way

### (Island Curb Cuts)

Intersection ID: 46810	Main Street: ARBOR_VISTA_DR	Cross Street: CLAUDE_FREEMAN_DR	Location: W
ADA ID: 72264727E0BE	Curb Cut Type: MedianRefuge2	Initial Pass/Fail: Fail	Overall Compliance: No
Codes/Mitigation Info/Possible Solution		Field Measurements/Component Compliance

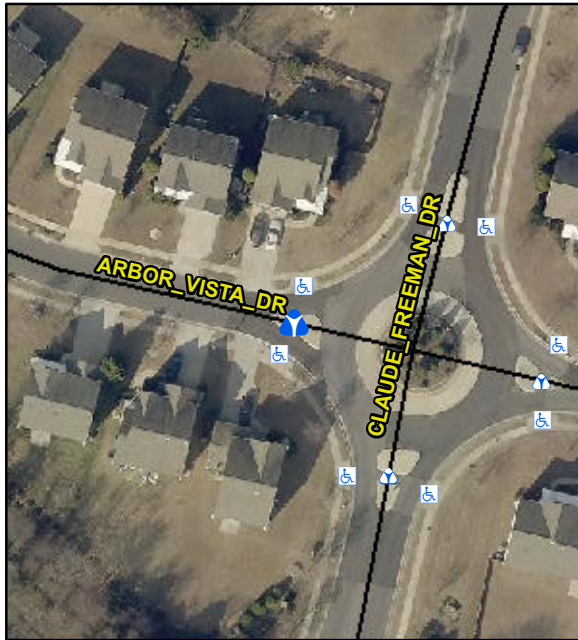
Compliance	Description	Data	Compliance	Description	Data
Yes	Refuge 1 Length (In)	42.0	N/A	Gutter 1 Ponding?	N/A
No	Refuge 1 Width (In)	59.0	N/A	Gutter 1 Lip Ht (In)	N/A
Yes	Refuge 1 Slope (%)	3.0	N/A	Gutter 1 Slope (%)	N/A
Yes	Refuge 1 X Slope (%)	2.0	N/A	Gutter 1 X Slope (%)	N/A
N/A	Painted X Walk1?	No	N/A	DWS 1 Provided?	N/A
N/A	X Walk 1 Direction	To N	N/A	DWS 1 Contrast?	N/A
N/A	X Walk 1 Width (In)	N/A	N/A	DWS 1 Length (In)	N/A
N/A	Road 1 Slope (%)	2.5	N/A	DWS 1 Full Width?	N/A
N/A	Road 1 X Slope (%)	1.6	N/A	DWS 1 Offset (In)	N/A
Yes	Refuge 2 Length (In)	42.0	N/A	Gutter 2 Ponding?	N/A
No	Refuge 2 Width (In)	59.0	N/A	Gutter 2 Lip Ht (In)	N/A
Yes	Refuge 2 Slope (%)	1.3	N/A	Gutter 2 Slope (%)	N/A
Yes	Refuge 2 X Slope (%)	1.4	N/A	Gutter 2 X Slope (%)	N/A
N/A	Painted X Walk2?	No	N/A	DWS 2 Provided?	N/A
N/A	X Walk 2 Direction	To S	N/A	DWS 2 Contrast?	N/A
N/A	X Walk 2 Width (In)	N/A	N/A	DWS 2 Length (In)	N/A

**Remove & Replace Entire Refuge.**
