# Access Compliance Report

## Public Rights-of-Way

### (Island Curb Cuts)

| Intersection ID: 10036503 | Main Street: ROZZELLES_FERRY_RD | Cross Street: N/A | Location: N/A |

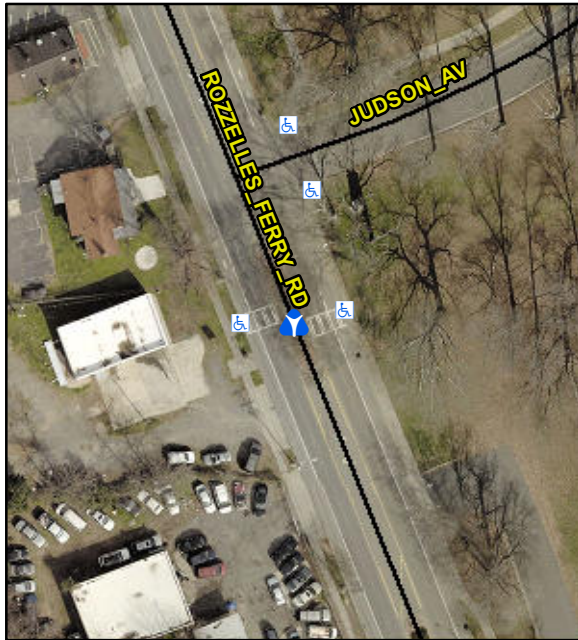
| ADA ID: 7266BF4F5E2A | Curb Cut Type: MedianRefuge2 | Initial Pass/Fail: Fail | Overall Compliance: No |

| Compliance | Description | Data | Compliance | Description | Data |
|---|---|---|---|---|---|
| No | Refuge 1 Width (In) | 51.5 | N/A | Gutter 1 Lip Ht (In) | N/A |
| No | Refuge 2 Width (In) | 51.5 | N/A | Gutter 2 Lip Ht (In) | N/A |
| No | Refuge 2 Slope (%) | 5.1 | N/A | Gutter 2 Slope (%) | N/A |

**Remove & Replace Entire Refuge.**

Total Cost: \$ 3000.00
