Access Compliance Report

Public Rights-of-Way

(Island Curb Cuts)

Intersection ID: 27040	Main Street: PIPER_GLEN_DR	Cross Street: REA_RD	Location: E
ADA ID: 72DFEF0C3F85	Curb Cut Type: MedianRefuge2	Initial Pass/Fail: Fail	Overall Compliance: No
Severity Score: 1.25			
Codes/Mitigation Info/Possible Solution		Field Measurements/Component Compliance

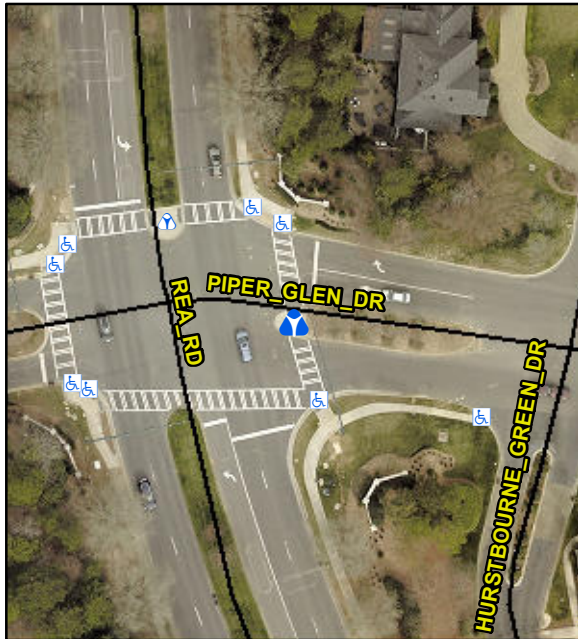
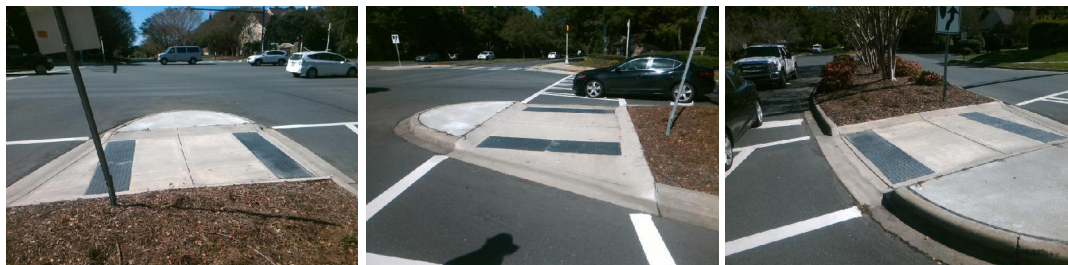
Compliance	Description	Data	Compliance	Description	Data
Yes	Refuge 1 Length (In)	70.5	N/A	Gutter 1 Ponding?	N/A
Yes	Refuge 1 Width (In)	99.0	N/A	Gutter 1 Lip Ht (In)	N/A
Yes	Refuge 1 Slope (%)	3.2	N/A	Gutter 1 Slope (%)	N/A
Yes	Refuge 1 X Slope (%)	3.3	N/A	Gutter 1 X Slope (%)	N/A
N/A	Painted X Walk1?	Yes	N/A	DWS 1 Provided?	N/A
N/A	X Walk 1 Direction	To N	N/A	DWS 1 Contrast?	N/A
N/A	X Walk 1 Width (In)	128.0	N/A	DWS 1 Length (In)	N/A
N/A	Road 1 Slope (%)	4.1	N/A	DWS 1 Full Width?	N/A
N/A	Road 1 X Slope (%)	0.3	N/A	DWS 1 Offset (In)	N/A
Yes	Refuge 2 Length (In)	70.5	N/A	Gutter 2 Ponding?	N/A
Yes	Refuge 2 Width (In)	99.0	N/A	Gutter 2 Lip Ht (In)	N/A
Yes	Refuge 2 Slope (%)	2.3	N/A	Gutter 2 Slope (%)	N/A
Yes	Refuge 2 X Slope (%)	2.9	N/A	Gutter 2 X Slope (%)	N/A
N/A	Painted X Walk2?	Yes	N/A	DWS 2 Provided?	N/A
N/A	X Walk 2 Direction	To S	N/A	DWS 2 Contrast?	N/A
N/A	X Walk 2 Width (In)	115.5	N/A	DWS 2 Length (In)	N/A

N/A	Road 2 Slope (%)	5.5	N/A	DWS 2 Full Width?	N/A
N/A	Road 2 X Slope (%)	0.9	N/A	DWS 2 Offset (In)	N/A
N/A	Refuge 3 Length (in)	N/A	N/A	Gutter 3 Ponding?	N/A
N/A	Refuge 3 Width (in)	N/A	N/A	Gutter 3 Lip Ht (in)	N/A
N/A	Refuge 3 Slope (%)	N/A	N/A	Gutter 3 Slope (%)	N/A
N/A	Refuge 3 XSlope (%)	N/A	N/A	Gutter 3 XSlope (%)	N/A
N/A	Painted X Walk3?	N/A	N/A	DWS 3 Provided?	N/A
N/A	X Walk 3 Direction	N/A	N/A	DWS 3 Contrast?	N/A
N/A	X Walk 3 Width (in)	N/A	N/A	DWS 3 Length (in)	N/A
N/A	Road 3 Slope (%)	N/A	N/A	DWS 3 Full Width?	N/A
N/A	Road 3 XSlope (%)	N/A	N/A	DWS 3 Offset (in)	N/A
Yes	Any Obstructions?	N/A	N/A	Storm Grate/Utility Hazard?	N/A
N/A	Obstruction Type		N/A	Storm Grate/Utility Type	
		N/A			N/A
N/A	Surface Condition	Good

Remove & Replace Entire Refuge.
