# Access Compliance Report

## Public Rights-of-Way

### (Island Curb Cuts)

Intersection ID: 3559	Main Street: PERIMETER_PY	Cross Street: W_W_T_HARRIS_BV	Location: NW
ADA ID: 73ADC8540824	Curb Cut Type: IslandRefuge3	Initial Pass/Fail: Fail	Overall Compliance: No
Severity Score: 60			
Codes/Mitigation Info/Possible Solution		Field Measurements/Component Compliance

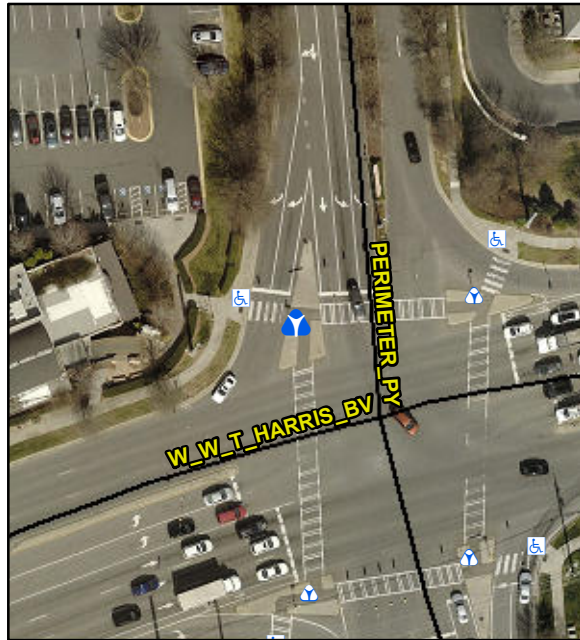
Compliance	Description	Data	Compliance	Description	Data
Yes	Refuge 1 Length (In)	64.0	N/A	Gutter 1 Ponding?	N/A
Yes	Refuge 1 Width (In)	72.0	N/A	Gutter 1 Lip Ht (In)	N/A
Yes	Refuge 1 Slope (%)	0.1	N/A	Gutter 1 Slope (%)	N/A
Yes	Refuge 1 X Slope (%)	0.8	N/A	Gutter 1 X Slope (%)	N/A
N/A	Painted X Walk1?	Yes	N/A	DWS 1 Provided?	N/A
N/A	X Walk 1 Direction	To NW	N/A	DWS 1 Contrast?	N/A
N/A	X Walk 1 Width (In)	120.0	N/A	DWS 1 Length (In)	N/A
N/A	Road 1 Slope (%)	2.7	N/A	DWS 1 Full Width?	N/A
N/A	Road 1 X Slope (%)	0.2	N/A	DWS 1 Offset (In)	N/A
Yes	Refuge 2 Length (In)	64.0	N/A	Gutter 2 Ponding?	N/A
Yes	Refuge 2 Width (In)	71.0	N/A	Gutter 2 Lip Ht (In)	N/A
Yes	Refuge 2 Slope (%)	0.2	N/A	Gutter 2 Slope (%)	N/A
Yes	Refuge 2 X Slope (%)	2.4	N/A	Gutter 2 X Slope (%)	N/A
N/A	Painted X Walk2?	Yes	N/A	DWS 2 Provided?	N/A
N/A	X Walk 2 Direction	To E	N/A	DWS 2 Contrast?	N/A
N/A	X Walk 2 Width (In)	112.0	N/A	DWS 2 Length (In)	N/A

N/A	Road 2 Slope (%)	1.9	N/A	DWS 2 Full Width?	N/A
N/A	Road 2 X Slope (%)	1.5	N/A	DWS 2 Offset (In)	N/A
Yes	Refuge 3 Length (in)	256.0	N/A	Gutter 3 Ponding?	N/A
Yes	Refuge 3 Width (in)	72.0	N/A	Gutter 3 Lip Ht (in)	N/A
No	Refuge 3 Slope (%)	7.7	N/A	Gutter 3 Slope (%)	N/A
Yes	Refuge 3 XSlope (%)	1.1	N/A	Gutter 3 XSlope (%)	N/A
N/A	Painted X Walk3?	Yes	N/A	DWS 3 Provided?	N/A
N/A	X Walk 3 Direction	To S	N/A	DWS 3 Contrast?	N/A
N/A	X Walk 3 Width (in)	113.0	N/A	DWS 3 Length (in)	N/A
N/A	Road 3 Slope (%)	2.1	N/A	DWS 3 Full Width?	N/A
N/A	Road 3 XSlope (%)	3.3	N/A	DWS 3 Offset (in)	N/A
Yes	Any Obstructions?	N/A	N/A	Storm Grate/Utility Hazard?	N/A
N/A	Obstruction Type		N/A	Storm Grate/Utility Type	
		N/A			N/A
N/A	Surface Condition	Good

**Remove & Replace Entire Refuge.**

Total Cost: \$ 3000.00
