Access Compliance Report

Public Rights-of-Way

(Island Curb Cuts)

Intersection ID: 18776	Main Street: SOUTH_BV	Cross Street: TYVOLA_RD	Location: N
ADA ID: 73D67A80A152	Curb Cut Type: MedianRefuge2	Initial Pass/Fail: Fail	Overall Compliance: No
Codes/Mitigation Info/Possible Solution		Field Measurements/Component Compliance

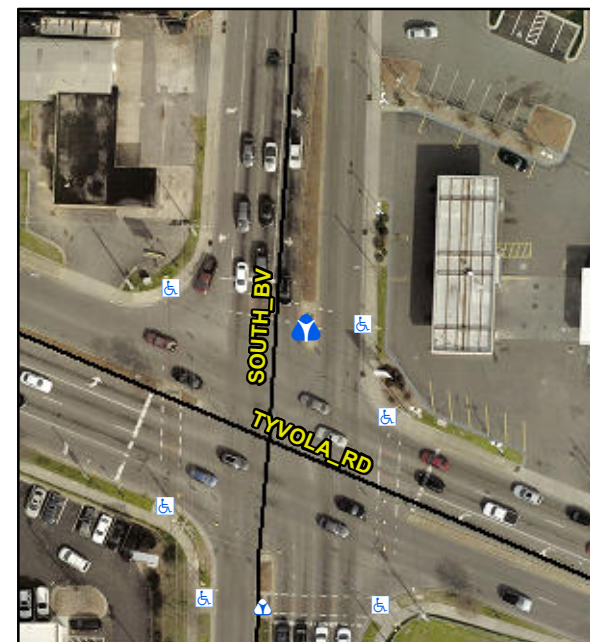
Compliance	Description	Data	Compliance	Description	Data
No	Refuge 1 Length (In)	31.0	N/A	Gutter 1 Ponding?	N/A
Yes	Refuge 1 Width (In)	91.0	N/A	Gutter 1 Lip Ht (In)	N/A
Yes	Refuge 1 Slope (%)	2.9	N/A	Gutter 1 Slope (%)	N/A
Yes	Refuge 1 X Slope (%)	3.2	N/A	Gutter 1 X Slope (%)	N/A
N/A	Painted X Walk1?	Yes	N/A	DWS 1 Provided?	N/A
N/A	X Walk 1 Direction	To E	N/A	DWS 1 Contrast?	N/A
N/A	X Walk 1 Width (In)	114.0	N/A	DWS 1 Length (In)	N/A
N/A	Road 1 Slope (%)	0.8	N/A	DWS 1 Full Width?	N/A
N/A	Road 1 X Slope (%)	2.3	N/A	DWS 1 Offset (In)	N/A
No	Refuge 2 Length (In)	31.0	N/A	Gutter 2 Ponding?	N/A
Yes	Refuge 2 Width (In)	91.0	N/A	Gutter 2 Lip Ht (In)	N/A
Yes	Refuge 2 Slope (%)	1.0	N/A	Gutter 2 Slope (%)	N/A
Yes	Refuge 2 X Slope (%)	3.5	N/A	Gutter 2 X Slope (%)	N/A
N/A	Painted X Walk2?	Yes	N/A	DWS 2 Provided?	N/A
N/A	X Walk 2 Direction	To W	N/A	DWS 2 Contrast?	N/A
N/A	X Walk 2 Width (In)	114.0	N/A	DWS 2 Length (In)	N/A

N/A	Road 2 Slope (%)	0.6	N/A	DWS 2 Full Width?	N/A
N/A	Road 2 X Slope (%)	0.7	N/A	DWS 2 Offset (In)	N/A
N/A	Refuge 3 Length (in)	N/A	N/A	Gutter 3 Ponding?	N/A
N/A	Refuge 3 Width (in)	N/A	N/A	Gutter 3 Lip Ht (in)	N/A
N/A	Refuge 3 Slope (%)	N/A	N/A	Gutter 3 Slope (%)	N/A
N/A	Refuge 3 XSlope (%)	N/A	N/A	Gutter 3 XSlope (%)	N/A
N/A	Painted X Walk3?	N/A	N/A	DWS 3 Provided?	N/A
N/A	X Walk 3 Direction	N/A	N/A	DWS 3 Contrast?	N/A
N/A	X Walk 3 Width (in)	N/A	N/A	DWS 3 Length (in)	N/A
N/A	Road 3 Slope (%)	N/A	N/A	DWS 3 Full Width?	N/A
N/A	Road 3 XSlope (%)	N/A	N/A	DWS 3 Offset (in)	N/A
Yes	Any Obstructions?	N/A	N/A	Storm Grate/Utility Hazard?	N/A
N/A	Obstruction Type		N/A	Storm Grate/Utility Type	
		N/A			N/A
N/A	Surface Condition	Good

Remove & Replace Entire Refuge.
