Access Compliance Report

Public Rights-of-Way

(Island Curb Cuts)

Intersection ID: 15457	Main Street: EAST_BV	Cross Street: LOMBARDY_CR	Location: NW
ADA ID: 73E58AE74A82	Curb Cut Type: MedianRefuge2	Initial Pass/Fail: Fail	Overall Compliance: No
Codes/Mitigation Info/Possible Solution		Field Measurements/Component Compliance	
Severity Score: 25

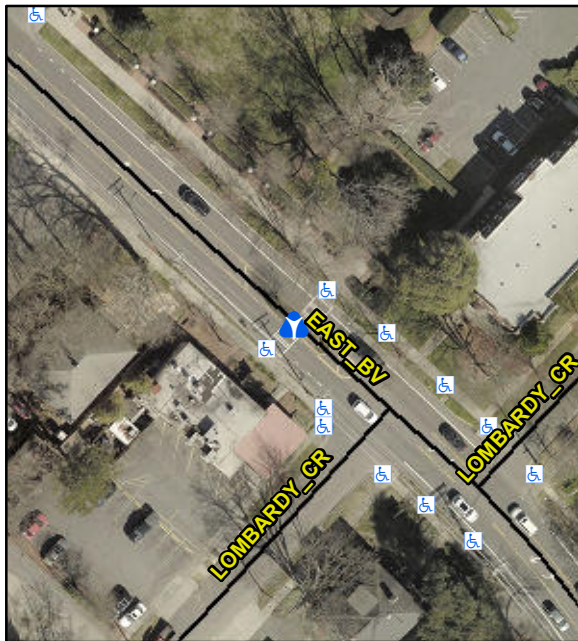
Compliance	Description	Data	Compliance	Description	Data
Yes	Refuge 1 Length (In)	51.5	N/A	Gutter 1 Ponding?	N/A
Yes	Refuge 1 Width (In)	102.0	N/A	Gutter 1 Lip Ht (In)	N/A
Yes	Refuge 1 Slope (%)	4.0	N/A	Gutter 1 Slope (%)	N/A
Yes	Refuge 1 X Slope (%)	2.8	N/A	Gutter 1 X Slope (%)	N/A
N/A	Painted X Walk1?	Yes	N/A	DWS 1 Provided?	N/A
N/A	X Walk 1 Direction	To SW	N/A	DWS 1 Contrast?	N/A
N/A	X Walk 1 Width (In)	113.0	N/A	DWS 1 Length (In)	N/A
N/A	Road 1 Slope (%)	3.9	N/A	DWS 1 Full Width?	N/A
N/A	Road 1 X Slope (%)	4.2	N/A	DWS 1 Offset (In)	N/A
Yes	Refuge 2 Length (In)	51.5	N/A	Gutter 2 Ponding?	N/A
Yes	Refuge 2 Width (In)	102.0	N/A	Gutter 2 Lip Ht (In)	N/A
No	Refuge 2 Slope (%)	5.4	N/A	Gutter 2 Slope (%)	N/A
No	Refuge 2 X Slope (%)	5.5	N/A	Gutter 2 X Slope (%)	N/A
N/A	Painted X Walk2?	Yes	N/A	DWS 2 Provided?	N/A
N/A	X Walk 2 Direction	To NE	N/A	DWS 2 Contrast?	N/A
N/A	X Walk 2 Width (In)	108.0	N/A	DWS 2 Length (In)	N/A

N/A	Road 2 Slope (%)	3.8	N/A	DWS 2 Full Width?	N/A
N/A	Road 2 X Slope (%)	5.8	N/A	DWS 2 Offset (In)	N/A
N/A	Refuge 3 Length (in)	N/A	N/A	Gutter 3 Ponding?	N/A
N/A	Refuge 3 Width (in)	N/A	N/A	Gutter 3 Lip Ht (in)	N/A
N/A	Refuge 3 Slope (%)	N/A	N/A	Gutter 3 Slope (%)	N/A
N/A	Refuge 3 XSlope (%)	N/A	N/A	Gutter 3 XSlope (%)	N/A
N/A	Painted X Walk3?	N/A	N/A	DWS 3 Provided?	N/A
N/A	X Walk 3 Direction	N/A	N/A	DWS 3 Contrast?	N/A
N/A	X Walk 3 Width (in)	N/A	N/A	DWS 3 Length (in)	N/A
N/A	Road 3 Slope (%)	N/A	N/A	DWS 3 Full Width?	N/A
N/A	Road 3 XSlope (%)	N/A	N/A	DWS 3 Offset (in)	N/A
Yes	Any Obstructions?	N/A	N/A	Storm Grate/Utility Hazard?	N/A
N/A	Obstruction Type		N/A	Storm Grate/Utility Type	
		N/A			N/A
N/A	Surface Condition	Good

Remove & Replace Entire Refuge.

\$ 3000.00
