Access Compliance Report

Public Rights-of-Way

(Island Curb Cuts)

Intersection ID: 20718	Main Street: PROVIDENCE_RD	Cross Street: EAST_BARDEN_RD	Location: NW
ADA ID: 74633E7F9365	Curb Cut Type: MedianRefuge2	Initial Pass/Fail: Fail	Overall Compliance: No
Codes/Mitigation Info/Possible Solution		Field Measurements/Component Compliance	
Severity Score: 0

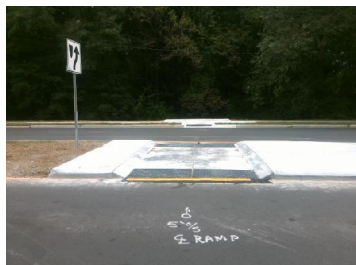
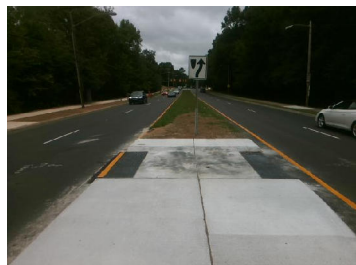
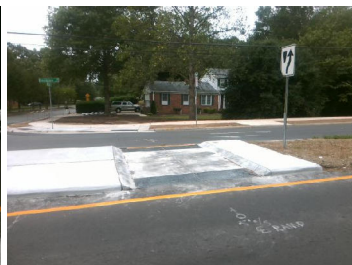
Compliance	Description	Data	Compliance	Description	Data
Yes	Refuge 1 Length (In)	74.5	N/A	Gutter 1 Ponding?	N/A
Yes	Refuge 1 Width (In)	96.0	N/A	Gutter 1 Lip Ht (In)	N/A
Yes	Refuge 1 Slope (%)	1.6	N/A	Gutter 1 Slope (%)	N/A
Yes	Refuge 1 X Slope (%)	3.7	N/A	Gutter 1 X Slope (%)	N/A
N/A	Painted X Walk1?	No	N/A	DWS 1 Provided?	N/A
N/A	X Walk 1 Direction	To SW	N/A	DWS 1 Contrast?	N/A
N/A	X Walk 1 Width (In)	N/A	N/A	DWS 1 Length (In)	N/A
N/A	Road 1 Slope (%)	2.3	N/A	DWS 1 Full Width?	N/A
N/A	Road 1 X Slope (%)	2.7	N/A	DWS 1 Offset (In)	N/A
Yes	Refuge 2 Length (In)	74.5	N/A	Gutter 2 Ponding?	N/A
Yes	Refuge 2 Width (In)	96.0	N/A	Gutter 2 Lip Ht (In)	N/A
Yes	Refuge 2 Slope (%)	1.6	N/A	Gutter 2 Slope (%)	N/A
Yes	Refuge 2 X Slope (%)	2.2	N/A	Gutter 2 X Slope (%)	N/A
N/A	Painted X Walk2?	No	N/A	DWS 2 Provided?	N/A
N/A	X Walk 2 Direction	To NE	N/A	DWS 2 Contrast?	N/A
N/A	X Walk 2 Width (In)	N/A	N/A	DWS 2 Length (In)	N/A

N/A	Road 2 Slope (%)	2.0	N/A	DWS 2 Full Width?	N/A
N/A	Road 2 X Slope (%)	3.0	N/A	DWS 2 Offset (In)	N/A
N/A	Refuge 3 Length (in)	N/A	N/A	Gutter 3 Ponding?	N/A
N/A	Refuge 3 Width (in)	N/A	N/A	Gutter 3 Lip Ht (in)	N/A
N/A	Refuge 3 Slope (%)	N/A	N/A	Gutter 3 Slope (%)	N/A
N/A	Refuge 3 XSlope (%)	N/A	N/A	Gutter 3 XSlope (%)	N/A
N/A	Painted X Walk3?	N/A	N/A	DWS 3 Provided?	N/A
N/A	X Walk 3 Direction	N/A	N/A	DWS 3 Contrast?	N/A
N/A	X Walk 3 Width (in)	N/A	N/A	DWS 3 Length (in)	N/A
N/A	Road 3 Slope (%)	N/A	N/A	DWS 3 Full Width?	N/A
N/A	Road 3 XSlope (%)	N/A	N/A	DWS 3 Offset (in)	N/A
Yes	Any Obstructions?	N/A	N/A	Storm Grate/Utility Hazard?	N/A
N/A	Obstruction Type		N/A	Storm Grate/Utility Type	
N/A	Surface Condition	Good	N/A		N/A

Remove & Replace Entire Refuge.
