Access Compliance Report

Public Rights-of-Way

(Island Curb Cuts)

Intersection ID: 21102	Main Street: S_TRYON_ST	Cross Street: AYRSLEY_TOWN_BV	Location: W
ADA ID: 74B31B1B9324	Curb Cut Type: MedianRefuge2	Initial Pass/Fail: Pass	Overall Compliance: No
Codes/Mitigation Info/Possible Solution		Field Measurements/Component Compliance	
Severity Score: 0

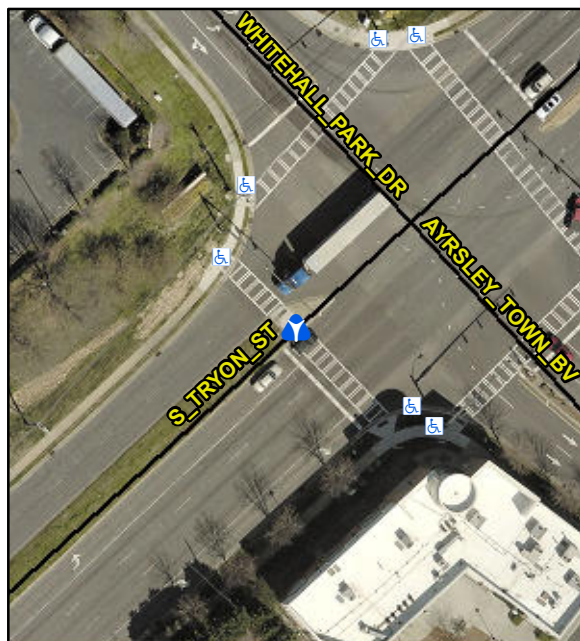
N/A	Road 2 Slope (%)	0.4	Yes	DWS 2 Full Width?	Yes
N/A	Road 2 X Slope (%)	2.5	No	DWS 2 Offset (In)	18.0
N/A	Refuge 3 Length (in)	N/A	N/A	Gutter 3 Ponding?	N/A
N/A	Refuge 3 Width (in)	N/A	N/A	Gutter 3 Lip Ht (in)	N/A
N/A	Refuge 3 Slope (%)	N/A	N/A	Gutter 3 Slope (%)	N/A
N/A	Refuge 3 XSlope (%)	N/A	N/A	Gutter 3 XSlope (%)	N/A
N/A	Painted X Walk3?	N/A	N/A	DWS 3 Provided?	N/A
N/A	X Walk 3 Direction	N/A	N/A	DWS 3 Contrast?	N/A
N/A	X Walk 3 Width (in)	N/A	N/A	DWS 3 Length (in)	N/A
N/A	Road 3 Slope (%)	N/A	N/A	DWS 3 Full Width?	N/A
N/A	Road 3 XSlope (%)	N/A	N/A	DWS 3 Offset (in)	N/A
Yes	Any Obstructions?	N/A	N/A	Storm Grate/Utility Hazard?	No
N/A	Obstruction Type		N/A	Storm Grate/Utility Type	
		N/A			N/A
N/A	Surface Condition	Good

Possible Solutions:

Remove & Replace Detectable Warning System.

Total Cost: \$ 1600.00
