# Access Compliance Report

## Public Rights-of-Way

### (Island Curb Cuts)

Intersection ID: 19730	Main Street: SOUTH_PARK_DR	Cross Street: MORRISON_BV	Location: SW
ADA ID: 74DA5CCB78D5	Curb Cut Type: IslandRefuge3	Initial Pass/Fail: Fail	Overall Compliance: No
Severity Score: 48.75			
Codes/Mitigation Info/Possible Solution		Field Measurements/Component Compliance

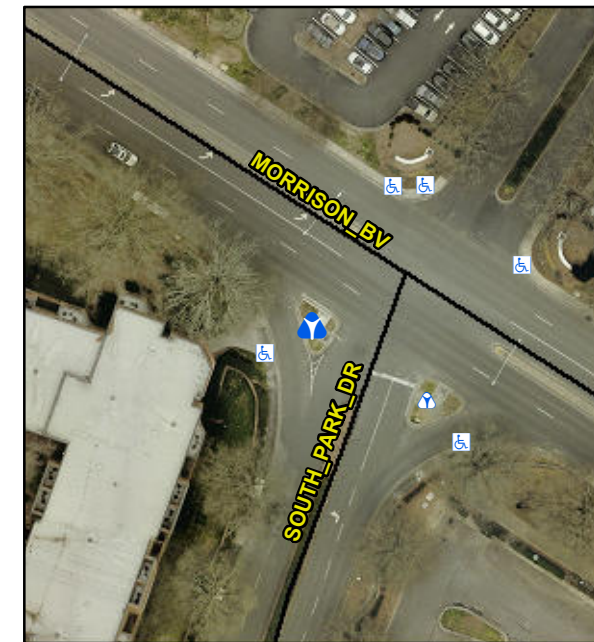
Compliance	Description	Data	Compliance	Description	Data
Yes	Refuge 1 Length (In)	58.0	N/A	Gutter 1 Ponding?	N/A
Yes	Refuge 1 Width (In)	62.0	N/A	Gutter 1 Lip Ht (In)	N/A
Yes	Refuge 1 Slope (%)	2.8	N/A	Gutter 1 Slope (%)	N/A
No	Refuge 1 X Slope (%)	5.1	N/A	Gutter 1 X Slope (%)	N/A
N/A	Painted X Walk1?	No	N/A	DWS 1 Provided?	N/A
N/A	X Walk 1 Direction	To SE	N/A	DWS 1 Contrast?	N/A
N/A	X Walk 1 Width (In)	N/A	N/A	DWS 1 Length (In)	N/A
N/A	Road 1 Slope (%)	5.7	N/A	DWS 1 Full Width?	N/A
N/A	Road 1 X Slope (%)	0.2	N/A	DWS 1 Offset (In)	N/A
Yes	Refuge 2 Length (In)	59.0	N/A	Gutter 2 Ponding?	N/A
Yes	Refuge 2 Width (In)	69.0	N/A	Gutter 2 Lip Ht (In)	N/A
Yes	Refuge 2 Slope (%)	1.3	N/A	Gutter 2 Slope (%)	N/A
Yes	Refuge 2 X Slope (%)	2.3	N/A	Gutter 2 X Slope (%)	N/A
N/A	Painted X Walk2?	No	N/A	DWS 2 Provided?	N/A
N/A	X Walk 2 Direction	To W	N/A	DWS 2 Contrast?	N/A
N/A	X Walk 2 Width (In)	N/A	N/A	DWS 2 Length (In)	N/A

N/A	Road 2 Slope (%)	3.7	N/A	DWS 2 Full Width?	N/A
N/A	Road 2 X Slope (%)	2.7	N/A	DWS 2 Offset (In)	N/A
Yes	Refuge 3 Length (in)	82.0	N/A	Gutter 3 Ponding?	N/A
Yes	Refuge 3 Width (in)	68.0	N/A	Gutter 3 Lip Ht (in)	N/A
Yes	Refuge 3 Slope (%)	3.3	N/A	Gutter 3 Slope (%)	N/A
Yes	Refuge 3 XSlope (%)	2.3	N/A	Gutter 3 XSlope (%)	N/A
N/A	Painted X Walk3?	No	N/A	DWS 3 Provided?	N/A
N/A	X Walk 3 Direction	To NE	N/A	DWS 3 Contrast?	N/A
N/A	X Walk 3 Width (in)	N/A	N/A	DWS 3 Length (in)	N/A
N/A	Road 3 Slope (%)	3.3	N/A	DWS 3 Full Width?	N/A
N/A	Road 3 XSlope (%)	3.9	N/A	DWS 3 Offset (in)	N/A
Yes	Any Obstructions?	N/A	N/A	Storm Grate/Utility Hazard?	N/A
N/A	Obstruction Type		N/A	Storm Grate/Utility Type	
		N/A			N/A
N/A	Surface Condition	Good

**Remove & Replace Entire Refuge.**

Total Cost: \$ 3000.00
