# Access Compliance Report

## Public Rights-of-Way

### (Island Curb Cuts)

Intersection ID: 27355	Main Street: N/A	Cross Street: N/A	Location: SW
ADA ID: 76BCCAED89A1	Curb Cut Type: MedianRefuge2	Initial Pass/Fail: Fail	Overall Compliance: No
Severity Score: 1.25			
Codes/Mitigation Info/Possible Solution		Field Measurements/Component Compliance

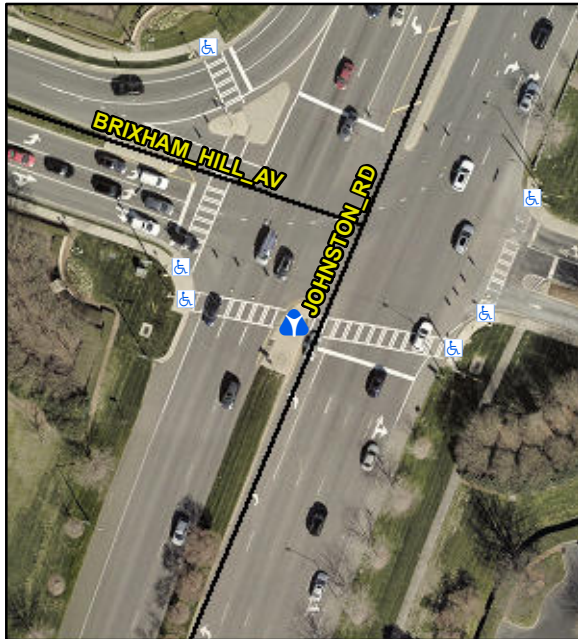
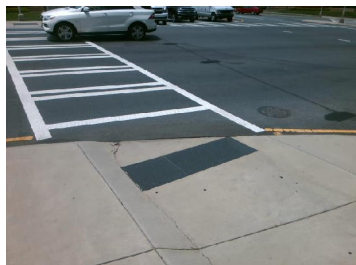
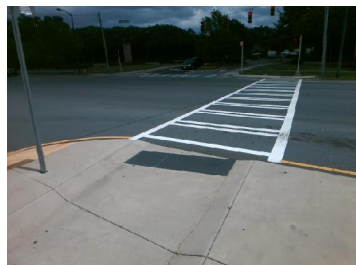
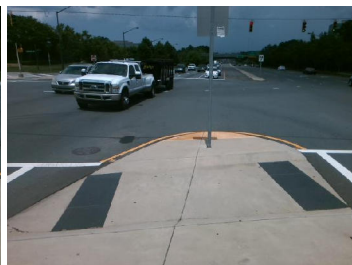
Compliance	Description	Data	Compliance	Description	Data
Yes	Refuge 1 Length (In)	82.0	N/A	Gutter 1 Ponding?	N/A
Yes	Refuge 1 Width (In)	72.0	N/A	Gutter 1 Lip Ht (In)	N/A
Yes	Refuge 1 Slope (%)	4.5	N/A	Gutter 1 Slope (%)	N/A
Yes	Refuge 1 X Slope (%)	3.6	N/A	Gutter 1 X Slope (%)	N/A
N/A	Painted X Walk1?	Yes	N/A	DWS 1 Provided?	N/A
N/A	X Walk 1 Direction	To W	N/A	DWS 1 Contrast?	N/A
N/A	X Walk 1 Width (In)	118.0	N/A	DWS 1 Length (In)	N/A
N/A	Road 1 Slope (%)	3.2	N/A	DWS 1 Full Width?	N/A
N/A	Road 1 X Slope (%)	0.6	N/A	DWS 1 Offset (In)	N/A
Yes	Refuge 2 Length (In)	82.0	N/A	Gutter 2 Ponding?	N/A
Yes	Refuge 2 Width (In)	72.0	N/A	Gutter 2 Lip Ht (In)	N/A
Yes	Refuge 2 Slope (%)	3.4	N/A	Gutter 2 Slope (%)	N/A
Yes	Refuge 2 X Slope (%)	2.9	N/A	Gutter 2 X Slope (%)	N/A
N/A	Painted X Walk2?	Yes	N/A	DWS 2 Provided?	N/A
N/A	X Walk 2 Direction	To E	N/A	DWS 2 Contrast?	N/A
N/A	X Walk 2 Width (In)	112.0	N/A	DWS 2 Length (In)	N/A

N/A	Road 2 Slope (%)	3.2	N/A	DWS 2 Full Width?	N/A
N/A	Road 2 X Slope (%)	6.7	N/A	DWS 2 Offset (In)	N/A
N/A	Refuge 3 Length (in)	N/A	N/A	Gutter 3 Ponding?	N/A
N/A	Refuge 3 Width (in)	N/A	N/A	Gutter 3 Lip Ht (in)	N/A
N/A	Refuge 3 Slope (%)	N/A	N/A	Gutter 3 Slope (%)	N/A
N/A	Refuge 3 XSlope (%)	N/A	N/A	Gutter 3 XSlope (%)	N/A
N/A	Painted X Walk3?	N/A	N/A	DWS 3 Provided?	N/A
N/A	X Walk 3 Direction	N/A	N/A	DWS 3 Contrast?	N/A
N/A	X Walk 3 Width (in)	N/A	N/A	DWS 3 Length (in)	N/A
N/A	Road 3 Slope (%)	N/A	N/A	DWS 3 Full Width?	N/A
N/A	Road 3 XSlope (%)	N/A	N/A	DWS 3 Offset (in)	N/A
Yes	Any Obstructions?	N/A	N/A	Storm Grate/Utility Hazard?	N/A
N/A	Obstruction Type		N/A	Storm Grate/Utility Type	
		N/A			N/A
N/A	Surface Condition	Good

**Remove & Replace Entire Refuge.**

Total Cost: \$ 3000.00
