Access Compliance Report

Public Rights-of-Way

(Island Curb Cuts)

Intersection ID: 23966	Main Street: CAROLINA_PAVILION_DR_N	Cross Street: SOUTH_BV	Location: W
ADA ID: 777009371B18	Curb Cut Type: MedianRefuge2	Initial Pass/Fail: Fail	Overall Compliance: No
Codes/Mitigation Info/Possible Solution		Field Measurements/Component Compliance	
Severity Score: 1.25

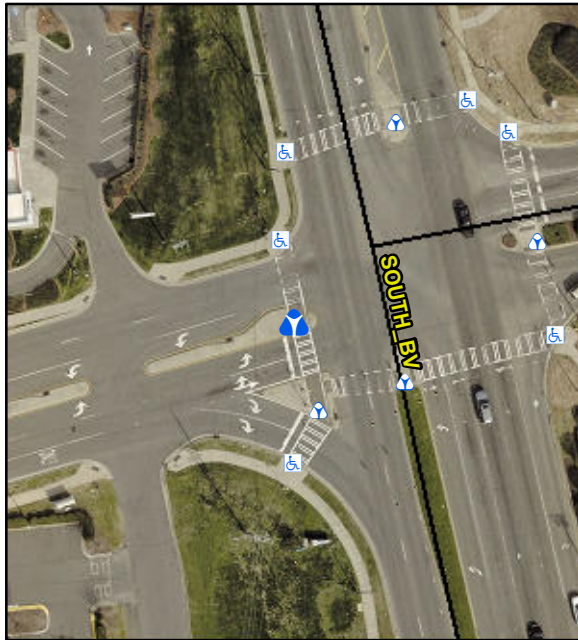
Compliance	Description	Data	Compliance	Description	Data
Yes	Refuge 1 Length (In)	55.0	N/A	Gutter 1 Ponding?	N/A
Yes	Refuge 1 Width (In)	120.0	N/A	Gutter 1 Lip Ht (In)	N/A
Yes	Refuge 1 Slope (%)	2.1	N/A	Gutter 1 Slope (%)	N/A
Yes	Refuge 1 X Slope (%)	3.6	N/A	Gutter 1 X Slope (%)	N/A
N/A	Painted X Walk1?	Yes	N/A	DWS 1 Provided?	N/A
N/A	X Walk 1 Direction	To SE	N/A	DWS 1 Contrast?	N/A
N/A	X Walk 1 Width (In)	96.0	N/A	DWS 1 Length (In)	N/A
N/A	Road 1 Slope (%)	4.1	N/A	DWS 1 Full Width?	N/A
N/A	Road 1 X Slope (%)	2.0	N/A	DWS 1 Offset (In)	N/A
Yes	Refuge 2 Length (In)	55.0	N/A	Gutter 2 Ponding?	N/A
Yes	Refuge 2 Width (In)	120.0	N/A	Gutter 2 Lip Ht (In)	N/A
Yes	Refuge 2 Slope (%)	2.8	N/A	Gutter 2 Slope (%)	N/A
Yes	Refuge 2 X Slope (%)	3.4	N/A	Gutter 2 X Slope (%)	N/A
N/A	Painted X Walk2?	Yes	N/A	DWS 2 Provided?	N/A
N/A	X Walk 2 Direction	To NW	N/A	DWS 2 Contrast?	N/A
N/A	X Walk 2 Width (In)	96.0	N/A	DWS 2 Length (In)	N/A

Possible Solutions:

Remove & Replace Entire Refuge.
