Access Compliance Report

Public Rights-of-Way

(Island Curb Cuts)

Intersection ID: 6555	Main Street: UNIVERSITY_CITY_BV	Cross Street: SANCTUARY_PL	Location: S
ADA ID: 77FA6D35801F	Curb Cut Type: MedianRefuge2	Initial Pass/Fail: Fail	Overall Compliance: No
Codes/Mitigation Info/Possible Solution		Field Measurements/Component Compliance

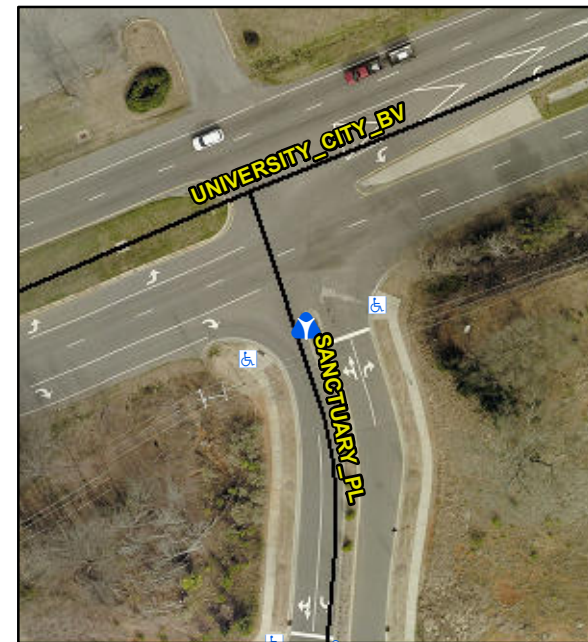
Compliance	Description	Data	Compliance	Description	Data
No	Refuge 1 Length (In)	35.5	N/A	Gutter 1 Ponding?	N/A
No	Refuge 1 Width (In)	48.0	N/A	Gutter 1 Lip Ht (In)	N/A
Yes	Refuge 1 Slope (%)	0.1	N/A	Gutter 1 Slope (%)	N/A
Yes	Refuge 1 X Slope (%)	3.0	N/A	Gutter 1 X Slope (%)	N/A
N/A	Painted X Walk1?	No	N/A	DWS 1 Provided?	N/A
N/A	X Walk 1 Direction	To W	N/A	DWS 1 Contrast?	N/A
N/A	X Walk 1 Width (In)	N/A	N/A	DWS 1 Length (In)	N/A
N/A	Road 1 Slope (%)	3.0	N/A	DWS 1 Full Width?	N/A
N/A	Road 1 X Slope (%)	3.2	N/A	DWS 1 Offset (In)	N/A
No	Refuge 2 Length (In)	35.5	N/A	Gutter 2 Ponding?	N/A
No	Refuge 2 Width (In)	48.0	N/A	Gutter 2 Lip Ht (In)	N/A
Yes	Refuge 2 Slope (%)	2.0	N/A	Gutter 2 Slope (%)	N/A
Yes	Refuge 2 X Slope (%)	1.6	N/A	Gutter 2 X Slope (%)	N/A
N/A	Painted X Walk2?	No	N/A	DWS 2 Provided?	N/A
N/A	X Walk 2 Direction	To E	N/A	DWS 2 Contrast?	N/A
N/A	X Walk 2 Width (In)	N/A	N/A	DWS 2 Length (In)	N/A
N/A	Road 2 Slope (%)	2.6	N/A	DWS 2 Full Width?	N/A

N/A	Road 2 X Slope (%)	5.5	N/A	DWS 2 Offset (In)	N/A
N/A	Refuge 3 Length (in)	N/A	N/A	Gutter 3 Ponding?	N/A
N/A	Refuge 3 Width (in)	N/A	N/A	Gutter 3 Lip Ht (in)	N/A
N/A	Refuge 3 Slope (%)	N/A	N/A	Gutter 3 Slope (%)	N/A
N/A	Refuge 3 XSlope (%)	N/A	N/A	Gutter 3 XSlope (%)	N/A
N/A	Painted X Walk3?	No	N/A	DWS 3 Provided?	N/A
N/A	X Walk 3 Direction	N/A	N/A	DWS 3 Contrast?	N/A
N/A	X Walk 3 Width (in)	N/A	N/A	DWS 3 Length (in)	N/A
N/A	Road 3 Slope (%)	N/A	N/A	DWS 3 Full Width?	N/A
N/A	Road 3 XSlope (%)	N/A	N/A	DWS 3 Offset (in)	N/A
Yes	Any Obstructions?	N/A	N/A	Storm Grate/Utility Hazard?	N/A
N/A	Obstruction Type		N/A	Storm Grate/Utility Type	
		N/A			N/A
N/A	Surface Condition	Good

Remove & Replace Entire Refuge.
