Access Compliance Report

Public Rights-of-Way

(Island Curb Cuts)

Intersection ID: 51054	Main Street: MULBERRY_CHURCH_RD	Cross Street: WESTPORT_RD	Location: SE
ADA ID: 794297AECE06	Curb Cut Type: MedianRefuge2	Initial Pass/Fail: Fail	Overall Compliance: No
Codes/Mitigation Info/Possible Solution		Field Measurements/Component Compliance	
Severity Score: 0

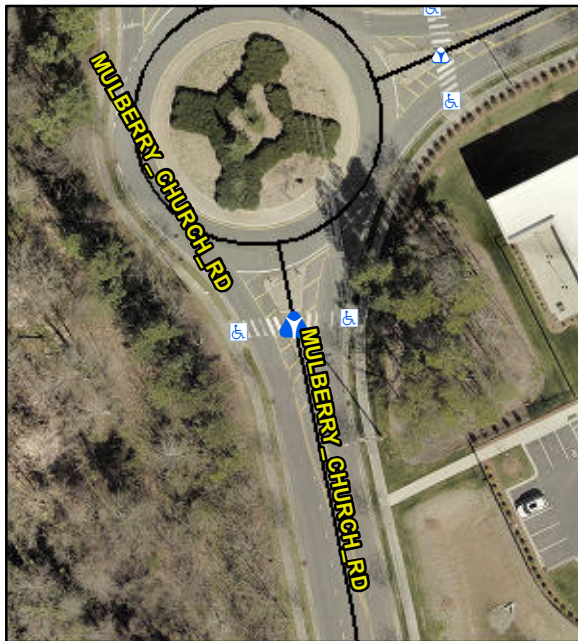
Compliance	Description	Data	Compliance	Description	Data
No	Refuge 1 Length (In)	30.0	N/A	Gutter 1 Ponding?	N/A
Yes	Refuge 1 Width (In)	136.0	N/A	Gutter 1 Lip Ht (In)	N/A
Yes	Refuge 1 Slope (%)	1.3	N/A	Gutter 1 Slope (%)	N/A
Yes	Refuge 1 X Slope (%)	0.9	N/A	Gutter 1 X Slope (%)	N/A
N/A	Painted X Walk1?	Yes	N/A	DWS 1 Provided?	N/A
N/A	X Walk 1 Direction	To E	N/A	DWS 1 Contrast?	N/A
N/A	X Walk 1 Width (In)	116.0	N/A	DWS 1 Length (In)	N/A
N/A	Road 1 Slope (%)	0.6	N/A	DWS 1 Full Width?	N/A
N/A	Road 1 X Slope (%)	0.0	N/A	DWS 1 Offset (In)	N/A
No	Refuge 2 Length (In)	30.0	N/A	Gutter 2 Ponding?	N/A
Yes	Refuge 2 Width (In)	136.0	N/A	Gutter 2 Lip Ht (In)	N/A
Yes	Refuge 2 Slope (%)	1.1	N/A	Gutter 2 Slope (%)	N/A
Yes	Refuge 2 X Slope (%)	2.1	N/A	Gutter 2 X Slope (%)	N/A
N/A	Painted X Walk2?	Yes	N/A	DWS 2 Provided?	N/A
N/A	X Walk 2 Direction	To W	N/A	DWS 2 Contrast?	N/A
N/A	X Walk 2 Width (In)	116.0	N/A	DWS 2 Length (In)	N/A

Remove & Replace Entire Refuge.
