Access Compliance Report Public Rights-of-Way (Island Curb Cuts)

Intersection ID: 5966	Main Street: SUNSTONE_DR	Cross Street: STATESVILLE_RD	Location: N
ADA ID: 794988D32590	Curb Cut Type: MedianRefuge2	Initial Pass/Fail: Pass	Overall Compliance: No Severity Score: 7.75

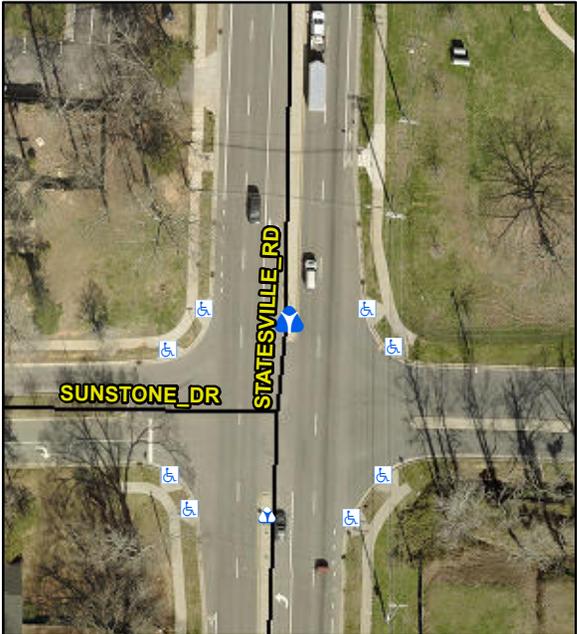
Compliance	Description	Data	Compliance	Description	Data
No	Refuge 1 Length (In)	35.5	No	Gutter 1 Ponding?	Yes
Yes	Refuge 1 Width (In)	95.5	No	Gutter 1 Lip Ht (In)	0.5
Yes	Refuge 1 Slope (%)	1.6	Yes	Gutter 1 Slope (%)	1.9
Yes	Refuge 1 X Slope (%)	1.4	Yes	Gutter 1 X Slope (%)	1.0
N/A	Painted X Walk1?	No	No	DWS 1 Provided?	Yes
N/A	X Walk 1 Direction	To W	N/A	DWS 1 Contrast?	Yes
N/A	X Walk 1 Width (In)	N/A	N/A	DWS 1 Length (In)	24.0
N/A	Road 1 Slope (%)	1.0	N/A	DWS 1 Full Width?	Yes
N/A	Road 1 X Slope (%)	0.8	N/A	DWS 1 Offset (In)	0.0
No	Refuge 2 Length (In)	35.5	No	Gutter 2 Ponding?	Yes
Yes	Refuge 2 Width (In)	95.5	No	Gutter 2 Lip Ht (In)	0.5
Yes	Refuge 2 Slope (%)	2.9	Yes	Gutter 2 Slope (%)	3.0
Yes	Refuge 2 X Slope (%)	0.7	Yes	Gutter 2 X Slope (%)	1.6
N/A	Painted X Walk2?	No	No	DWS 2 Provided?	Yes
N/A	X Walk 2 Direction	To NE	N/A	DWS 2 Contrast?	Yes
N/A	X Walk 2 Width (In)	N/A	N/A	DWS 2 Length (In)	24.0
N/A	Road 2 Slope (%)	1.0	N/A	DWS 2 Full Width?	Yes

N/A	Road 2 X Slope (%)	2.7	N/A	DWS 2 Offset (In)	0.0
N/A	Refuge 3 Length (in)	N/A	N/A	Gutter 3 Ponding?	No
N/A	Refuge 3 Width (in)	N/A	N/A	Gutter 3 Lip Ht (in)	N/A
N/A	Refuge 3 Slope (%)	N/A	N/A	Gutter 3 Slope (%)	N/A
N/A	Refuge 3 XSlope (%)	N/A	N/A	Gutter 3 XSlope (%)	N/A
N/A	Painted X Walk3?	No	N/A	DWS 3 Provided?	N/A
N/A	X Walk 3 Direction	N/A	N/A	DWS 3 Contrast?	N/A
N/A	X Walk 3 Width (in)	N/A	N/A	DWS 3 Length (in)	N/A
N/A	Road 3 Slope (%)	N/A	N/A	DWS 3 Full Width?	N/A
N/A	Road 3 XSlope (%)	N/A	N/A	DWS 3 Offset (in)	N/A
Yes	Any Obstructions?	No	N/A	Storm Grate/Utility Hazard?	No
N/A	Obstruction Type		N/A	Storm Grate/Utility Type	
			N/A		N/A
N/A	Surface Condition	Good

Possible Solutions:
**Remove & Replace Entire Refuge.
Grind Gutter Lip.**
