# Access Compliance Report

## Public Rights-of-Way

### (Island Curb Cuts)

Intersection ID: 27942	Main Street: COMMUNITY HOUSE RD	Cross Street: NORTH COMMUNITY HOUSE RD	Location: NE
ADA ID: 79CFA4F1D46A	Curb Cut Type: MedianRefuge2	Initial Pass/Fail: Fail	Overall Compliance: No
Severity Score: 25			
Codes/Mitigation Info/Possible Solution		Field Measurements/Component Compliance

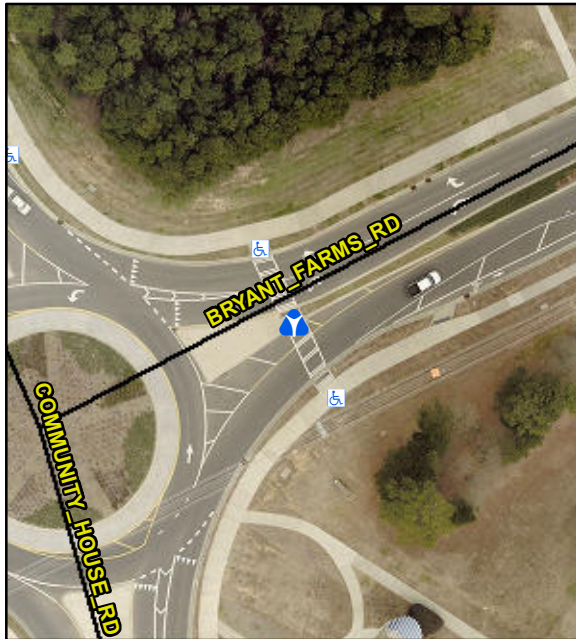
Compliance	Description	Data	Compliance	Description	Data
No	Refuge 1 Length (In)	35.5	N/A	Gutter 1 Ponding?	N/A
Yes	Refuge 1 Width (In)	118.0	N/A	Gutter 1 Lip Ht (In)	N/A
No	Refuge 1 Slope (%)	5.4	N/A	Gutter 1 Slope (%)	N/A
No	Refuge 1 X Slope (%)	5.4	N/A	Gutter 1 X Slope (%)	N/A
N/A	Painted X Walk1?	Yes	N/A	DWS 1 Provided?	N/A
N/A	X Walk 1 Direction	To SE	N/A	DWS 1 Contrast?	N/A
N/A	X Walk 1 Width (In)	110.0	N/A	DWS 1 Length (In)	N/A
N/A	Road 1 Slope (%)	1.4	N/A	DWS 1 Full Width?	N/A
N/A	Road 1 X Slope (%)	1.5	N/A	DWS 1 Offset (In)	N/A
No	Refuge 2 Length (In)	35.5	N/A	Gutter 2 Ponding?	N/A
Yes	Refuge 2 Width (In)	118.0	N/A	Gutter 2 Lip Ht (In)	N/A
Yes	Refuge 2 Slope (%)	0.4	N/A	Gutter 2 Slope (%)	N/A
Yes	Refuge 2 X Slope (%)	4.0	N/A	Gutter 2 X Slope (%)	N/A
N/A	Painted X Walk2?	Yes	N/A	DWS 2 Provided?	N/A
N/A	X Walk 2 Direction	To NW	N/A	DWS 2 Contrast?	N/A
N/A	X Walk 2 Width (In)	111.0	N/A	DWS 2 Length (In)	N/A

N/A	Road 2 Slope (%)	2.0	N/A	DWS 2 Full Width?	N/A
N/A	Road 2 X Slope (%)	3.0	N/A	DWS 2 Offset (In)	N/A
N/A	Refuge 3 Length (in)	N/A	N/A	Gutter 3 Ponding?	N/A
N/A	Refuge 3 Width (in)	N/A	N/A	Gutter 3 Lip Ht (in)	N/A
N/A	Refuge 3 Slope (%)	N/A	N/A	Gutter 3 Slope (%)	N/A
N/A	Refuge 3 XSlope (%)	N/A	N/A	Gutter 3 XSlope (%)	N/A
N/A	Painted X Walk3?	N/A	N/A	DWS 3 Provided?	N/A
N/A	X Walk 3 Direction	N/A	N/A	DWS 3 Contrast?	N/A
N/A	X Walk 3 Width (in)	N/A	N/A	DWS 3 Length (in)	N/A
N/A	Road 3 Slope (%)	N/A	N/A	DWS 3 Full Width?	N/A
N/A	Road 3 XSlope (%)	N/A	N/A	DWS 3 Offset (in)	N/A
Yes	Any Obstructions?	N/A	N/A	Storm Grate/Utility Hazard?	N/A
N/A	Obstruction Type		N/A	Storm Grate/Utility Type	
		N/A			N/A
N/A	Surface Condition	Good

**Remove & Replace Entire Refuge.**
