Access Compliance Report

Public Rights-of-Way

(Island Curb Cuts)

Intersection ID: 43075	Main Street: SCOTT_AV	Cross Street: ROMANY_RD	Location: S
ADA ID: 7BD5E708D563	Curb Cut Type: IslandRefuge3	Initial Pass/Fail: Fail	Overall Compliance: No
Severity Score: 60			
Codes/Mitigation Info/Possible Solution		Field Measurements/Component Compliance

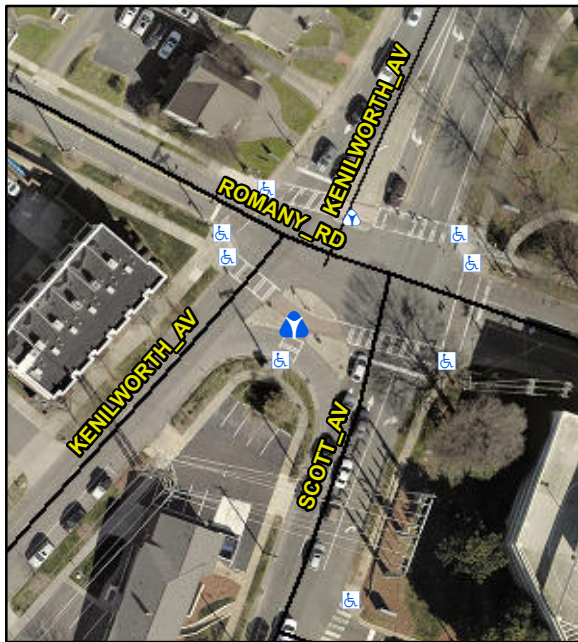
N/A	Road 2 Slope (%)	2.6	N/A	DWS 2 Full Width?	N/A
N/A	Road 2 X Slope (%)	1.2	N/A	DWS 2 Offset (In)	N/A
Yes	Refuge 3 Length (in)	55.0	N/A	Gutter 3 Ponding?	N/A
Yes	Refuge 3 Width (in)	96.0	N/A	Gutter 3 Lip Ht (in)	N/A
No	Refuge 3 Slope (%)	7.0	N/A	Gutter 3 Slope (%)	N/A
Yes	Refuge 3 XSlope (%)	0.3	N/A	Gutter 3 XSlope (%)	N/A
N/A	Painted X Walk3?	Yes	N/A	DWS 3 Provided?	N/A
N/A	X Walk 3 Direction	To S	N/A	DWS 3 Contrast?	N/A
N/A	X Walk 3 Width (in)	113.0	N/A	DWS 3 Length (in)	N/A
N/A	Road 3 Slope (%)	1.0	N/A	DWS 3 Full Width?	N/A
N/A	Road 3 XSlope (%)	9.0	N/A	DWS 3 Offset (in)	N/A
Yes	Any Obstructions?	N/A	N/A	Storm Grate/Utility Hazard?	N/A
N/A	Obstruction Type		N/A	Storm Grate/Utility Type	
			N/A		N/A
N/A	Surface Condition	Good

Remove & Replace Entire Refuge.
