Access Compliance Report

Public Rights-of-Way

(Island Curb Cuts)

| Intersection ID: 15542 | Main Street: CLANTON_RD | Cross Street: N_CLANTON_TO_S_I-77_RA_NB | Location: S |

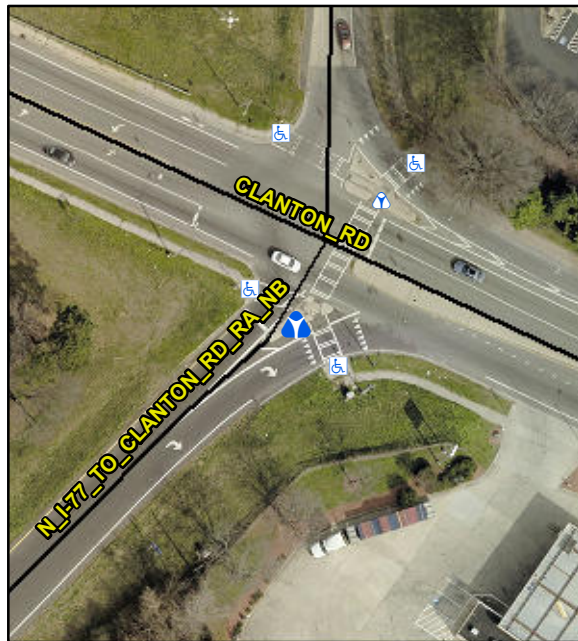
| ADA ID: 7D48D900607B | Curb Cut Type: IslandRefuge3 | Initial Pass/Fail: Fail | Overall Compliance: No |

| Compliance | Description | Data | Compliance | Description | Data |
|---|---|---|---|---|---|
| No | Refuge 1 Width (In) | 59.0 | N/A | Gutter 1 Lip Ht (In) | N/A |
| No | Refuge 2 Width (In) | 59.0 | N/A | Gutter 2 Lip Ht (In) | N/A |
| No | Refuge 3 Width (in) | 58.0 | N/A | Gutter 3 Lip Ht (in) | N/A |

Remove & Replace Entire Refuge.
