Access Compliance Report

Public Rights-of-Way

(Island Curb Cuts)

Intersection ID: 44555	Main Street: UNIVERSITY_CITY_BV	Cross Street: N_TRYON_ST	Location: SW
ADA ID: 7D7475358BB7	Curb Cut Type: IslandRefuge3	Initial Pass/Fail: Fail	Overall Compliance: No
Codes/Mitigation Info/Possible Solution		Field Measurements/Component Compliance

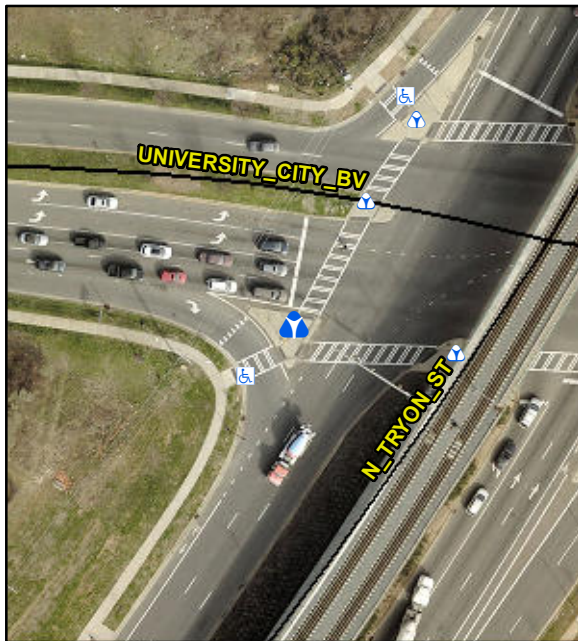
Compliance	Description	Data	Compliance	Description	Data
No	Refuge 1 Length (In)	144.0	Yes	Gutter 1 Ponding?	N/A
Yes	Refuge 1 Width (In)	95.0	No	Gutter 1 Lip Ht (In)	2.0
Yes	Refuge 1 Slope (%)	1.6	No	Gutter 1 Slope (%)	N/A
Yes	Refuge 1 X Slope (%)	2.7	No	Gutter 1 X Slope (%)	N/A
N/A	Painted X Walk1?	Yes	N/A	DWS 1 Provided?	N/A
N/A	X Walk 1 Direction	To NE	N/A	DWS 1 Contrast?	N/A
N/A	X Walk 1 Width (In)	125.0	N/A	DWS 1 Length (In)	N/A
N/A	Road 1 Slope (%)	3.4	N/A	DWS 1 Full Width?	N/A
N/A	Road 1 X Slope (%)	3.5	N/A	DWS 1 Offset (In)	N/A
No	Refuge 2 Length (In)	30.0	Yes	Gutter 2 Ponding?	N/A
Yes	Refuge 2 Width (In)	110.0	No	Gutter 2 Lip Ht (In)	2.0
Yes	Refuge 2 Slope (%)	3.2	No	Gutter 2 Slope (%)	N/A
Yes	Refuge 2 X Slope (%)	0.9	No	Gutter 2 X Slope (%)	N/A
N/A	Painted X Walk2?	Yes	N/A	DWS 2 Provided?	N/A
N/A	X Walk 2 Direction	To E	N/A	DWS 2 Contrast?	N/A
N/A	X Walk 2 Width (In)	120.0	N/A	DWS 2 Length (In)	N/A

N/A	Road 2 Slope (%)	0.2	N/A	DWS 2 Full Width?	N/A
N/A	Road 2 X Slope (%)	2.8	N/A	DWS 2 Offset (In)	N/A
No	Refuge 3 Length (in)	40.0	Yes	Gutter 3 Ponding?	N/A
Yes	Refuge 3 Width (in)	94.0	No	Gutter 3 Lip Ht (in)	2.0
Yes	Refuge 3 Slope (%)	1.3	No	Gutter 3 Slope (%)	N/A
Yes	Refuge 3 XSlope (%)	2.3	No	Gutter 3 XSlope (%)	N/A
N/A	Painted X Walk3?	Yes	N/A	DWS 3 Provided?	N/A
N/A	X Walk 3 Direction	To SW	N/A	DWS 3 Contrast?	N/A
N/A	X Walk 3 Width (in)	120.0	N/A	DWS 3 Length (in)	N/A
N/A	Road 3 Slope (%)	3.2	N/A	DWS 3 Full Width?	N/A
N/A	Road 3 XSlope (%)	1.5	N/A	DWS 3 Offset (in)	N/A
Yes	Any Obstructions?	N/A	N/A	Storm Grate/Utility Hazard?	N/A
N/A	Obstruction Type		N/A	Storm Grate/Utility Type	
			N/A		N/A
N/A	Surface Condition	Good

Possible Solutions:

Remove & Replace Entire Refuge.
Remove & Replace Gutter.
