Access Compliance Report

Public Rights-of-Way

(Island Curb Cuts)

Intersection ID: 11108	Main Street: TUCKASEEGEE_RD	Cross Street: BERRYHILL_RD	Location:	N
ADA ID: 7E0C7CF7F7C7	Curb Cut Type: MedianRefuge2	Initial Pass/Fail: Fail	Overall Compliance: No	Severity Score: 10
Codes/Mitigation Info/Possible Solution		Field Measurements/Component Compliance

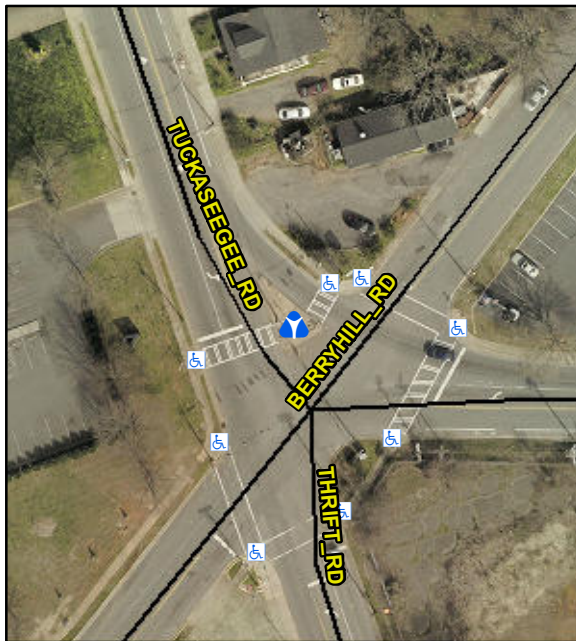
Compliance	Description	Data	Compliance	Description	Data
Yes	Refuge 1 Length (In)	115.5	N/A	Gutter 1 Ponding?	N/A
No	Refuge 1 Width (In)	58.5	N/A	Gutter 1 Lip Ht (In)	N/A
Yes	Refuge 1 Slope (%)	0.6	N/A	Gutter 1 Slope (%)	N/A
Yes	Refuge 1 X Slope (%)	2.4	N/A	Gutter 1 X Slope (%)	N/A
N/A	Painted X Walk1?	Yes	N/A	DWS 1 Provided?	N/A
N/A	X Walk 1 Direction	To W	N/A	DWS 1 Contrast?	N/A
N/A	X Walk 1 Width (In)	111.0	N/A	DWS 1 Length (In)	N/A
N/A	Road 1 Slope (%)	2.0	N/A	DWS 1 Full Width?	N/A
N/A	Road 1 X Slope (%)	4.7	N/A	DWS 1 Offset (In)	N/A
Yes	Refuge 2 Length (In)	115.5	N/A	Gutter 2 Ponding?	N/A
No	Refuge 2 Width (In)	58.5	N/A	Gutter 2 Lip Ht (In)	N/A
Yes	Refuge 2 Slope (%)	2.5	N/A	Gutter 2 Slope (%)	N/A
Yes	Refuge 2 X Slope (%)	2.2	N/A	Gutter 2 X Slope (%)	N/A
N/A	Painted X Walk2?	Yes	N/A	DWS 2 Provided?	N/A
N/A	X Walk 2 Direction	To E	N/A	DWS 2 Contrast?	N/A
N/A	X Walk 2 Width (In)	109.0	N/A	DWS 2 Length (In)	N/A

Remove & Replace Entire Refuge.
