# Access Compliance Report

## Public Rights-of-Way

### (Island Curb Cuts)

Intersection ID: 15806	Main Street: EAST_BV	Cross Street: MARYLAND_AV	Location: NW
ADA ID: 7E57172E1A03	Curb Cut Type: MedianRefuge2	Initial Pass/Fail: Fail	Overall Compliance: No
Severity Score: 0			
Codes/Mitigation Info/Possible Solution		Field Measurements/Component Compliance

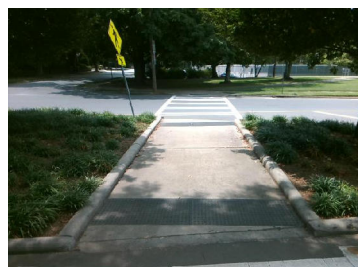
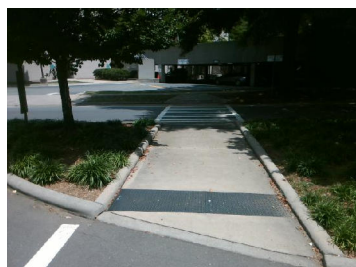
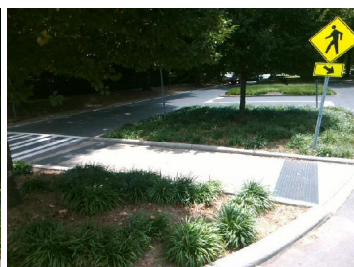
Compliance	Description	Data	Compliance	Description	Data
Yes	Refuge 1 Length (In)	114.5	N/A	Gutter 1 Ponding?	N/A
Yes	Refuge 1 Width (In)	94.0	N/A	Gutter 1 Lip Ht (In)	N/A
Yes	Refuge 1 Slope (%)	0.3	N/A	Gutter 1 Slope (%)	N/A
Yes	Refuge 1 X Slope (%)	2.3	N/A	Gutter 1 X Slope (%)	N/A
N/A	Painted X Walk1?	Yes	N/A	DWS 1 Provided?	N/A
N/A	X Walk 1 Direction	To SW	N/A	DWS 1 Contrast?	N/A
N/A	X Walk 1 Width (In)	111.0	N/A	DWS 1 Length (In)	N/A
N/A	Road 1 Slope (%)	1.6	N/A	DWS 1 Full Width?	N/A
N/A	Road 1 X Slope (%)	1.1	N/A	DWS 1 Offset (In)	N/A
Yes	Refuge 2 Length (In)	114.5	N/A	Gutter 2 Ponding?	N/A
Yes	Refuge 2 Width (In)	94.0	N/A	Gutter 2 Lip Ht (In)	N/A
Yes	Refuge 2 Slope (%)	1.3	N/A	Gutter 2 Slope (%)	N/A
Yes	Refuge 2 X Slope (%)	0.7	N/A	Gutter 2 X Slope (%)	N/A
N/A	Painted X Walk2?	Yes	N/A	DWS 2 Provided?	N/A
N/A	X Walk 2 Direction	To NE	N/A	DWS 2 Contrast?	N/A
N/A	X Walk 2 Width (In)	111.0	N/A	DWS 2 Length (In)	N/A

N/A	Road 2 Slope (%)	0.0	N/A	DWS 2 Full Width?	N/A
N/A	Road 2 X Slope (%)	0.7	N/A	DWS 2 Offset (In)	N/A
N/A	Refuge 3 Length (in)	N/A	N/A	Gutter 3 Ponding?	N/A
N/A	Refuge 3 Width (in)	N/A	N/A	Gutter 3 Lip Ht (in)	N/A
N/A	Refuge 3 Slope (%)	N/A	N/A	Gutter 3 Slope (%)	N/A
N/A	Refuge 3 XSlope (%)	N/A	N/A	Gutter 3 XSlope (%)	N/A
N/A	Painted X Walk3?	N/A	N/A	DWS 3 Provided?	N/A
N/A	X Walk 3 Direction	N/A	N/A	DWS 3 Contrast?	N/A
N/A	X Walk 3 Width (in)	N/A	N/A	DWS 3 Length (in)	N/A
N/A	Road 3 Slope (%)	N/A	N/A	DWS 3 Full Width?	N/A
N/A	Road 3 XSlope (%)	N/A	N/A	DWS 3 Offset (in)	N/A
Yes	Any Obstructions?	N/A	N/A	Storm Grate/Utility Hazard?	N/A
N/A	Obstruction Type		N/A	Storm Grate/Utility Type	
		N/A			N/A
N/A	Surface Condition	Good

**Remove & Replace Entire Refuge.**
