Access Compliance Report

Public Rights-of-Way

(Island Curb Cuts)

Intersection ID: 6611	Main Street: N_TRYON_ST	Cross Street: W_ROCKY_RIVER_RD	Location: SE
ADA ID: 7EEDD4093FA0	Curb Cut Type: MedianRefuge2	Initial Pass/Fail: Pass	Overall Compliance: No
Severity Score: 0			
Codes/Mitigation Info/Possible Solution		Field Measurements/Component Compliance

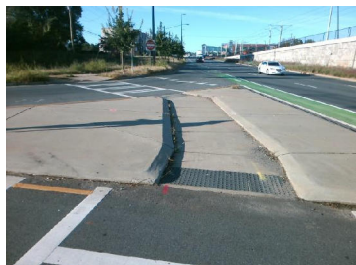
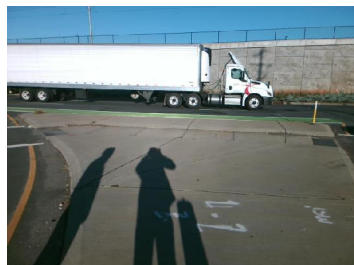
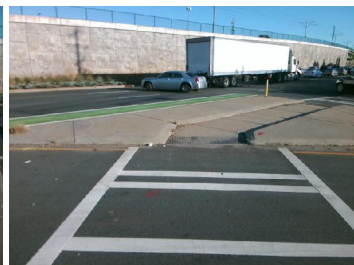
N/A	Road 2 Slope (%)	0.3	Yes	DWS 2 Full Width?	Yes
N/A	Road 2 X Slope (%)	1.6	No	DWS 2 Offset (In)	3.5
N/A	Refuge 3 Length (in)	N/A	N/A	Gutter 3 Ponding?	N/A
N/A	Refuge 3 Width (in)	N/A	N/A	Gutter 3 Lip Ht (in)	N/A
N/A	Refuge 3 Slope (%)	N/A	N/A	Gutter 3 Slope (%)	N/A
N/A	Refuge 3 XSlope (%)	N/A	N/A	Gutter 3 XSlope (%)	N/A
N/A	Painted X Walk3?	N/A	N/A	DWS 3 Provided?	N/A
N/A	X Walk 3 Direction	N/A	N/A	DWS 3 Contrast?	N/A
N/A	X Walk 3 Width (in)	N/A	N/A	DWS 3 Length (in)	N/A
N/A	Road 3 Slope (%)	N/A	N/A	DWS 3 Full Width?	N/A
N/A	Road 3 XSlope (%)	N/A	N/A	DWS 3 Offset (in)	N/A
Yes	Any Obstructions?	N/A	N/A	Storm Grate/Utility Hazard?	No
N/A	Obstruction Type		N/A	Storm Grate/Utility Type	
		N/A			N/A
N/A	Surface Condition	Good

Remove & Replace Detectable Warning System.
