Access Compliance Report

Public Rights-of-Way

(Island Curb Cuts)

Intersection ID: 10025611	Main Street: E_WOODLAWN_RD	Cross Street: N/A	Location: E
ADA ID: 7EF4B2B73CAC	Curb Cut Type: MedianRefuge2	Initial Pass/Fail: Fail	Overall Compliance: No
Codes/Mitigation Info/Possible Solution		Field Measurements/Component Compliance

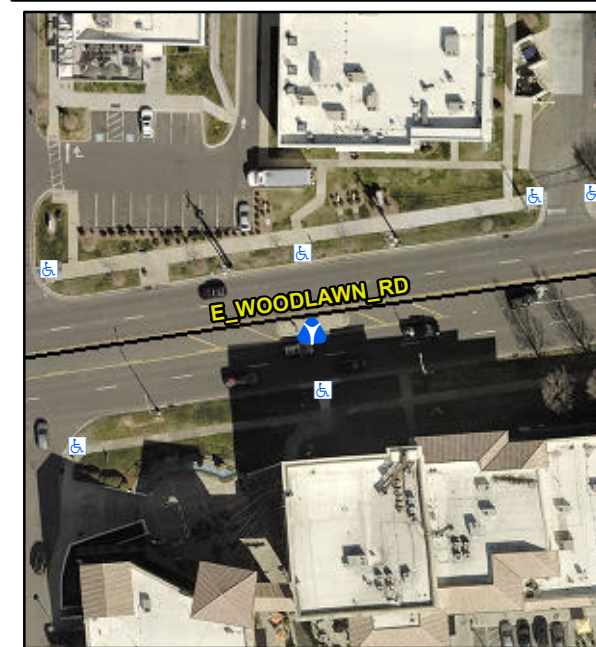
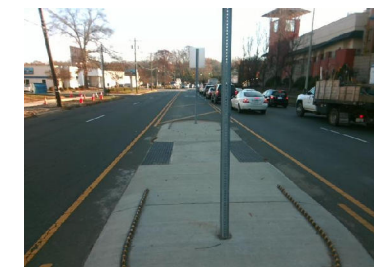
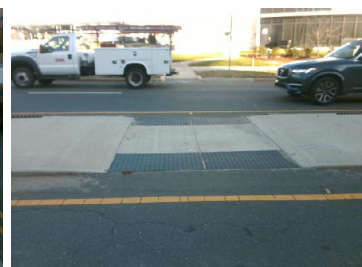
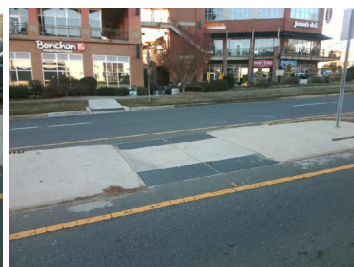
Compliance	Description	Data	Compliance	Description	Data
Yes	Refuge 1 Length (In)	53.5	N/A	Gutter 1 Ponding?	N/A
Yes	Refuge 1 Width (In)	96.0	N/A	Gutter 1 Lip Ht (In)	N/A
Yes	Refuge 1 Slope (%)	1.3	N/A	Gutter 1 Slope (%)	N/A
Yes	Refuge 1 X Slope (%)	3.3	N/A	Gutter 1 X Slope (%)	N/A
N/A	Painted X Walk1?	No	N/A	DWS 1 Provided?	N/A
N/A	X Walk 1 Direction	To N	N/A	DWS 1 Contrast?	N/A
N/A	X Walk 1 Width (In)	N/A	N/A	DWS 1 Length (In)	N/A
N/A	Road 1 Slope (%)	2.7	N/A	DWS 1 Full Width?	N/A
N/A	Road 1 X Slope (%)	2.1	N/A	DWS 1 Offset (In)	N/A
Yes	Refuge 2 Length (In)	53.5	N/A	Gutter 2 Ponding?	N/A
Yes	Refuge 2 Width (In)	96.0	N/A	Gutter 2 Lip Ht (In)	N/A
Yes	Refuge 2 Slope (%)	1.5	N/A	Gutter 2 Slope (%)	N/A
Yes	Refuge 2 X Slope (%)	3.9	N/A	Gutter 2 X Slope (%)	N/A
N/A	Painted X Walk2?	No	N/A	DWS 2 Provided?	N/A
N/A	X Walk 2 Direction	To S	N/A	DWS 2 Contrast?	N/A
N/A	X Walk 2 Width (In)	N/A	N/A	DWS 2 Length (In)	N/A

N/A	Road 2 Slope (%)	3.4	N/A	DWS 2 Full Width?	N/A
N/A	Road 2 X Slope (%)	0.3	N/A	DWS 2 Offset (In)	N/A
N/A	Refuge 3 Length (in)	N/A	N/A	Gutter 3 Ponding?	N/A
N/A	Refuge 3 Width (in)	N/A	N/A	Gutter 3 Lip Ht (in)	N/A
N/A	Refuge 3 Slope (%)	N/A	N/A	Gutter 3 Slope (%)	N/A
N/A	Refuge 3 XSlope (%)	N/A	N/A	Gutter 3 XSlope (%)	N/A
N/A	Painted X Walk3?	N/A	N/A	DWS 3 Provided?	N/A
N/A	X Walk 3 Direction	N/A	N/A	DWS 3 Contrast?	N/A
N/A	X Walk 3 Width (in)	N/A	N/A	DWS 3 Length (in)	N/A
N/A	Road 3 Slope (%)	N/A	N/A	DWS 3 Full Width?	N/A
N/A	Road 3 XSlope (%)	N/A	N/A	DWS 3 Offset (in)	N/A
Yes	Any Obstructions?	N/A	N/A	Storm Grate/Utility Hazard?	N/A
N/A	Obstruction Type		N/A	Storm Grate/Utility Type	
		N/A			N/A
N/A	Surface Condition	Good

Remove & Replace Entire Refuge.

\$ 3000.00
