Access Compliance Report

Public Rights-of-Way

(Island Curb Cuts)

Intersection ID: 52288	Main Street: STEELE_CREEK_RD	Cross Street: DIXIE_RIVER_RD	Location: W
ADA ID: 7F3AEB35B702	Curb Cut Type: MedianRefuge2	Initial Pass/Fail: Fail	Overall Compliance: No
Severity Score: 12.5			
Codes/Mitigation Info/Possible Solution		Field Measurements/Component Compliance

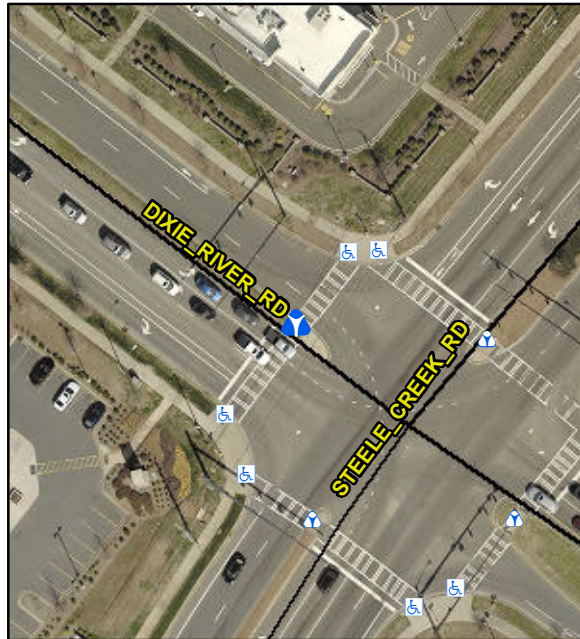
Compliance	Description	Data	Compliance	Description	Data
Yes	Refuge 1 Length (In)	50.5	N/A	Gutter 1 Ponding?	N/A
Yes	Refuge 1 Width (In)	99	N/A	Gutter 1 Lip Ht (In)	N/A
Yes	Refuge 1 Slope (%)	0.2	N/A	Gutter 1 Slope (%)	N/A
No	Refuge 1 X Slope (%)	8.4	N/A	Gutter 1 X Slope (%)	N/A
N/A	Painted X Walk1?	Yes	N/A	DWS 1 Provided?	N/A
N/A	X Walk 1 Direction	To NE	N/A	DWS 1 Contrast?	N/A
N/A	X Walk 1 Width (In)	111	N/A	DWS 1 Length (In)	N/A
N/A	Road 1 Slope (%)	2.7	N/A	DWS 1 Full Width?	N/A
N/A	Road 1 X Slope (%)	0.7	N/A	DWS 1 Offset (In)	N/A
Yes	Refuge 2 Length (In)	50.5	N/A	Gutter 2 Ponding?	N/A
Yes	Refuge 2 Width (In)	99	N/A	Gutter 2 Lip Ht (In)	N/A
Yes	Refuge 2 Slope (%)	1.7	N/A	Gutter 2 Slope (%)	N/A
Yes	Refuge 2 X Slope (%)	1.8	N/A	Gutter 2 X Slope (%)	N/A
N/A	Painted X Walk2?	Yes	N/A	DWS 2 Provided?	N/A
N/A	X Walk 2 Direction	To SW	N/A	DWS 2 Contrast?	N/A
N/A	X Walk 2 Width (In)	110	N/A	DWS 2 Length (In)	N/A

Remove & Replace Entire Refuge.

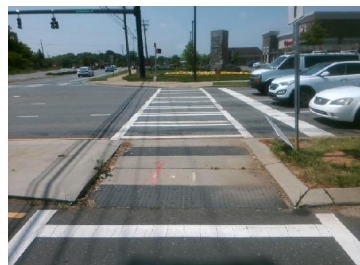
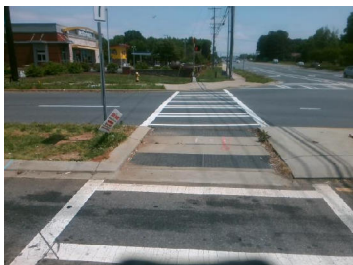
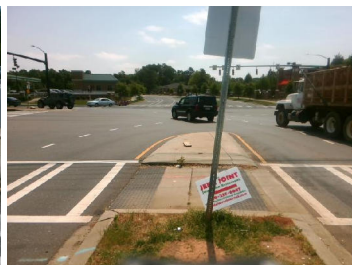
N/A	Road 2 Slope (%)	0.6	N/A	DWS 2 Full Width?	N/A
N/A	Road 2 X Slope (%)	1.7	N/A	DWS 2 Offset (In)	N/A
N/A	Refuge 3 Length (in)	N/A	N/A	Gutter 3 Ponding?	N/A
N/A	Refuge 3 Width (in)	N/A	N/A	Gutter 3 Lip Ht (in)	N/A
N/A	Refuge 3 Slope (%)	N/A	N/A	Gutter 3 Slope (%)	N/A
N/A	Refuge 3 XSlope (%)	N/A	N/A	Gutter 3 XSlope (%)	N/A
N/A	Painted X Walk3?	N/A	N/A	DWS 3 Provided?	N/A
N/A	X Walk 3 Direction	N/A	N/A	DWS 3 Contrast?	N/A
N/A	X Walk 3 Width (in)	N/A	N/A	DWS 3 Length (in)	N/A
N/A	Road 3 Slope (%)	N/A	N/A	DWS 3 Full Width?	N/A
N/A	Road 3 XSlope (%)	N/A	N/A	DWS 3 Offset (in)	N/A
Yes	Any Obstructions?	N/A	N/A	Storm Grate/Utility Hazard?	N/A
N/A	Obstruction Type		N/A	Storm Grate/Utility Type	
		N/A			N/A
N/A	Surface Condition	Good
