# Access Compliance Report

## Public Rights-of-Way

### (Island Curb Cuts)

Intersection ID: 16151	Main Street: FREELAND_LN	Cross Street: S_TRYON_ST	Location:	N
ADA ID: 8056662CDE21	Curb Cut Type: MedianRefuge2	Initial Pass/Fail: Fail	Overall Compliance: No	Severity Score: 0
Codes/Mitigation Info/Possible Solution		Field Measurements/Component Compliance

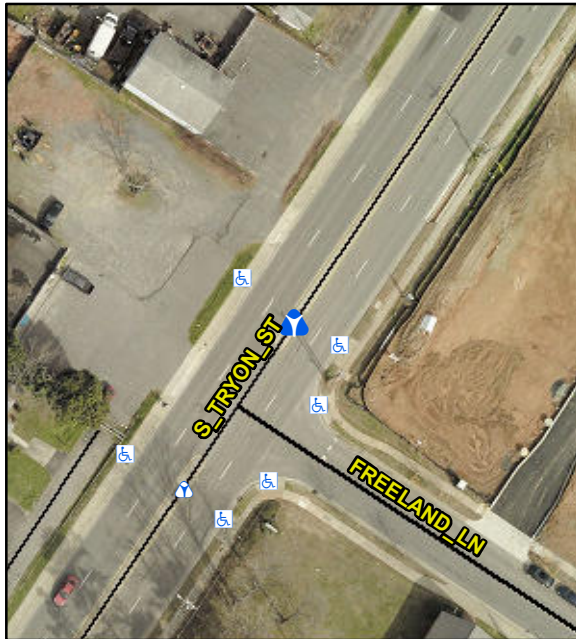
Compliance	Description	Data	Compliance	Description	Data
No	Refuge 1 Length (In)	31.0	N/A	Gutter 1 Ponding?	N/A
Yes	Refuge 1 Width (In)	122.0	N/A	Gutter 1 Lip Ht (In)	N/A
Yes	Refuge 1 Slope (%)	1.7	N/A	Gutter 1 Slope (%)	N/A
Yes	Refuge 1 X Slope (%)	2.9	N/A	Gutter 1 X Slope (%)	N/A
N/A	Painted X Walk1?	No	N/A	DWS 1 Provided?	N/A
N/A	X Walk 1 Direction	To SE	N/A	DWS 1 Contrast?	N/A
N/A	X Walk 1 Width (In)	N/A	N/A	DWS 1 Length (In)	N/A
N/A	Road 1 Slope (%)	0.2	N/A	DWS 1 Full Width?	N/A
N/A	Road 1 X Slope (%)	4.8	N/A	DWS 1 Offset (In)	N/A
No	Refuge 2 Length (In)	31.0	N/A	Gutter 2 Ponding?	N/A
Yes	Refuge 2 Width (In)	122.0	N/A	Gutter 2 Lip Ht (In)	N/A
Yes	Refuge 2 Slope (%)	0.1	N/A	Gutter 2 Slope (%)	N/A
Yes	Refuge 2 X Slope (%)	1.4	N/A	Gutter 2 X Slope (%)	N/A
N/A	Painted X Walk2?	No	N/A	DWS 2 Provided?	N/A
N/A	X Walk 2 Direction	To NW	N/A	DWS 2 Contrast?	N/A
N/A	X Walk 2 Width (In)	N/A	N/A	DWS 2 Length (In)	N/A

N/A	Road 2 Slope (%)	1.8	N/A	DWS 2 Full Width?	N/A
N/A	Road 2 X Slope (%)	3.6	N/A	DWS 2 Offset (In)	N/A
N/A	Refuge 3 Length (in)	N/A	N/A	Gutter 3 Ponding?	N/A
N/A	Refuge 3 Width (in)	N/A	N/A	Gutter 3 Lip Ht (in)	N/A
N/A	Refuge 3 Slope (%)	N/A	N/A	Gutter 3 Slope (%)	N/A
N/A	Refuge 3 XSlope (%)	N/A	N/A	Gutter 3 XSlope (%)	N/A
N/A	Painted X Walk3?	N/A	N/A	DWS 3 Provided?	N/A
N/A	X Walk 3 Direction	N/A	N/A	DWS 3 Contrast?	N/A
N/A	X Walk 3 Width (in)	N/A	N/A	DWS 3 Length (in)	N/A
N/A	Road 3 Slope (%)	N/A	N/A	DWS 3 Full Width?	N/A
N/A	Road 3 XSlope (%)	N/A	N/A	DWS 3 Offset (in)	N/A
Yes	Any Obstructions?	N/A	N/A	Storm Grate/Utility Hazard?	N/A
N/A	Obstruction Type		N/A	Storm Grate/Utility Type	
		N/A			N/A
N/A	Surface Condition	Good

**Remove & Replace Entire Refuge.**

**\$ 3000.00**
