Access Compliance Report

Public Rights-of-Way

(Island Curb Cuts)

Intersection ID: 12013	Main Street: FREEDOM_DR	Cross Street: W_MOREHEAD_ST	Location: W
ADA ID: 80B39F8427D8	Curb Cut Type: MedianRefuge2	Initial Pass/Fail: Fail	Overall Compliance: No
Codes/Mitigation Info/Possible Solution		Field Measurements/Component Compliance	
Severity Score: 12.5

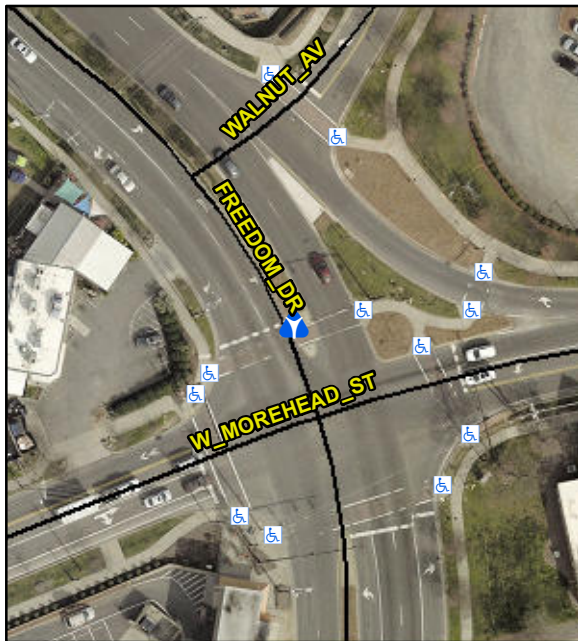
Compliance	Description	Data	Compliance	Description	Data
Yes	Refuge 1 Length (In)	36.0	N/A	Gutter 1 Ponding?	N/A
Yes	Refuge 1 Width (In)	144.0	N/A	Gutter 1 Lip Ht (In)	N/A
No	Refuge 1 Slope (%)	6.4	N/A	Gutter 1 Slope (%)	N/A
Yes	Refuge 1 X Slope (%)	1.9	N/A	Gutter 1 X Slope (%)	N/A
N/A	Painted X Walk1?	Yes	N/A	DWS 1 Provided?	N/A
N/A	X Walk 1 Direction	To W	N/A	DWS 1 Contrast?	N/A
N/A	X Walk 1 Width (In)	114.0	N/A	DWS 1 Length (In)	N/A
N/A	Road 1 Slope (%)	1.6	N/A	DWS 1 Full Width?	N/A
N/A	Road 1 X Slope (%)	9.3	N/A	DWS 1 Offset (In)	N/A
Yes	Refuge 2 Length (In)	36.0	N/A	Gutter 2 Ponding?	N/A
Yes	Refuge 2 Width (In)	140.0	N/A	Gutter 2 Lip Ht (In)	N/A
No	Refuge 2 Slope (%)	6.1	N/A	Gutter 2 Slope (%)	N/A
Yes	Refuge 2 X Slope (%)	1.9	N/A	Gutter 2 X Slope (%)	N/A
N/A	Painted X Walk2?	Yes	N/A	DWS 2 Provided?	N/A
N/A	X Walk 2 Direction	To E	N/A	DWS 2 Contrast?	N/A
N/A	X Walk 2 Width (In)	114.0	N/A	DWS 2 Length (In)	N/A

N/A	Road 2 Slope (%)	1.1	N/A	DWS 2 Full Width?	N/A
N/A	Road 2 X Slope (%)	6.6	N/A	DWS 2 Offset (In)	N/A
N/A	Refuge 3 Length (in)	N/A	N/A	Gutter 3 Ponding?	N/A
N/A	Refuge 3 Width (in)	N/A	N/A	Gutter 3 Lip Ht (in)	N/A
N/A	Refuge 3 Slope (%)	N/A	N/A	Gutter 3 Slope (%)	N/A
N/A	Refuge 3 XSlope (%)	N/A	N/A	Gutter 3 XSlope (%)	N/A
N/A	Painted X Walk3?	N/A	N/A	DWS 3 Provided?	N/A
N/A	X Walk 3 Direction	N/A	N/A	DWS 3 Contrast?	N/A
N/A	X Walk 3 Width (in)	N/A	N/A	DWS 3 Length (in)	N/A
N/A	Road 3 Slope (%)	N/A	N/A	DWS 3 Full Width?	N/A
N/A	Road 3 XSlope (%)	N/A	N/A	DWS 3 Offset (in)	N/A
Yes	Any Obstructions?	N/A	N/A	Storm Grate/Utility Hazard?	N/A
N/A	Obstruction Type		N/A	Storm Grate/Utility Type	
			N/A		N/A
N/A	Surface Condition	Good

Possible Solutions:

Remove & Replace Entire Refuge.

Total Cost: \$ 3000.00
