Access Compliance Report

Public Rights-of-Way

(Island Curb Cuts)

Intersection ID: 10033070	Main Street: NORTH_COMMUNITY_HOUSE_RD	Cross Street: N/A	Location: N
ADA ID: 81F825E3B9B9	Curb Cut Type: MedianRefuge2	Initial Pass/Fail: Fail	Overall Compliance: No
Codes/Mitigation Info/Possible Solution		Field Measurements/Component Compliance

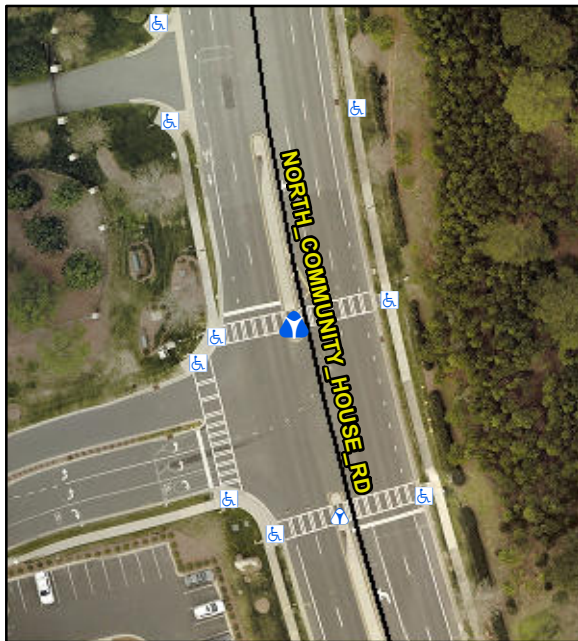
Compliance	Description	Data	Compliance	Description	Data
No	Refuge 1 Length (In)	34.5	N/A	Gutter 1 Ponding?	N/A
Yes	Refuge 1 Width (In)	120.0	N/A	Gutter 1 Lip Ht (In)	N/A
No	Refuge 1 Slope (%)	5.9	N/A	Gutter 1 Slope (%)	N/A
Yes	Refuge 1 X Slope (%)	2.9	N/A	Gutter 1 X Slope (%)	N/A
N/A	Painted X Walk1?	Yes	N/A	DWS 1 Provided?	N/A
N/A	X Walk 1 Direction	To E	N/A	DWS 1 Contrast?	N/A
N/A	X Walk 1 Width (In)	110.0	N/A	DWS 1 Length (In)	N/A
N/A	Road 1 Slope (%)	3.7	N/A	DWS 1 Full Width?	N/A
N/A	Road 1 X Slope (%)	5.0	N/A	DWS 1 Offset (In)	N/A
No	Refuge 2 Length (In)	34.5	N/A	Gutter 2 Ponding?	N/A
Yes	Refuge 2 Width (In)	120.0	N/A	Gutter 2 Lip Ht (In)	N/A
Yes	Refuge 2 Slope (%)	1.6	N/A	Gutter 2 Slope (%)	N/A
Yes	Refuge 2 X Slope (%)	3.4	N/A	Gutter 2 X Slope (%)	N/A
N/A	Painted X Walk2?	Yes	N/A	DWS 2 Provided?	N/A
N/A	X Walk 2 Direction	To W	N/A	DWS 2 Contrast?	N/A
N/A	X Walk 2 Width (In)	110.0	N/A	DWS 2 Length (In)	N/A

Remove & Replace Entire Refuge.

Total Cost: \$ 3000.00
