Access Compliance Report

Public Rights-of-Way

(Island Curb Cuts)

Intersection ID: 10630	Main Street: E_SUGAR_CREEK_RD	Cross Street: EASTWAY_DR	Location: SW
ADA ID: 82862C9C9302	Curb Cut Type: MedianRefuge2	Initial Pass/Fail: Fail	Overall Compliance: No
Codes/Mitigation Info/Possible Solution		Field Measurements/Component Compliance

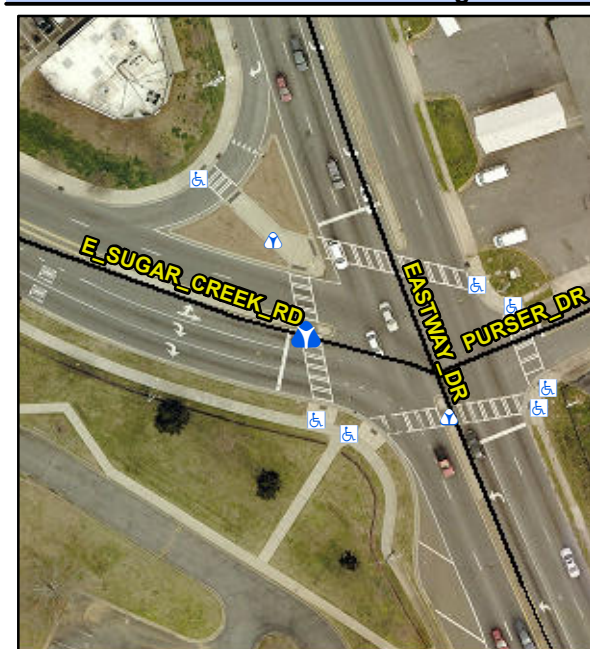
Compliance	Description	Data	Compliance	Description	Data
No	Refuge 1 Length (In)	26.5	N/A	Gutter 1 Ponding?	N/A
Yes	Refuge 1 Width (In)	104.5	N/A	Gutter 1 Lip Ht (In)	N/A
Yes	Refuge 1 Slope (%)	1.7	N/A	Gutter 1 Slope (%)	N/A
No	Refuge 1 X Slope (%)	5.1	N/A	Gutter 1 X Slope (%)	N/A
N/A	Painted X Walk1?	Yes	N/A	DWS 1 Provided?	N/A
N/A	X Walk 1 Direction	To NW	N/A	DWS 1 Contrast?	N/A
N/A	X Walk 1 Width (In)	120.5	N/A	DWS 1 Length (In)	N/A
N/A	Road 1 Slope (%)	5.3	N/A	DWS 1 Full Width?	N/A
N/A	Road 1 X Slope (%)	1.8	N/A	DWS 1 Offset (In)	N/A
No	Refuge 2 Length (In)	26.5	N/A	Gutter 2 Ponding?	N/A
Yes	Refuge 2 Width (In)	104.5	N/A	Gutter 2 Lip Ht (In)	N/A
Yes	Refuge 2 Slope (%)	2.1	N/A	Gutter 2 Slope (%)	N/A
No	Refuge 2 X Slope (%)	5.9	N/A	Gutter 2 X Slope (%)	N/A
N/A	Painted X Walk2?	Yes	N/A	DWS 2 Provided?	N/A
N/A	X Walk 2 Direction	To SE	N/A	DWS 2 Contrast?	N/A
N/A	X Walk 2 Width (In)	117.0	N/A	DWS 2 Length (In)	N/A

N/A	Road 2 Slope (%)	5.5	N/A	DWS 2 Full Width?	N/A
N/A	Road 2 X Slope (%)	2.2	N/A	DWS 2 Offset (In)	N/A
N/A	Refuge 3 Length (in)	N/A	N/A	Gutter 3 Ponding?	N/A
N/A	Refuge 3 Width (in)	N/A	N/A	Gutter 3 Lip Ht (in)	N/A
N/A	Refuge 3 Slope (%)	N/A	N/A	Gutter 3 Slope (%)	N/A
N/A	Refuge 3 XSlope (%)	N/A	N/A	Gutter 3 XSlope (%)	N/A
N/A	Painted X Walk3?	N/A	N/A	DWS 3 Provided?	N/A
N/A	X Walk 3 Direction	N/A	N/A	DWS 3 Contrast?	N/A
N/A	X Walk 3 Width (in)	N/A	N/A	DWS 3 Length (in)	N/A
N/A	Road 3 Slope (%)	N/A	N/A	DWS 3 Full Width?	N/A
N/A	Road 3 XSlope (%)	N/A	N/A	DWS 3 Offset (in)	N/A
Yes	Any Obstructions?	N/A	N/A	Storm Grate/Utility Hazard?	N/A
N/A	Obstruction Type		N/A	Storm Grate/Utility Type	
		N/A			N/A
N/A	Surface Condition	Good

Remove & Replace Entire Refuge.
