Access Compliance Report

Public Rights-of-Way

(Island Curb Cuts)

Intersection ID: 13404	Main Street: LEXINGTON_AV	Cross Street: E_CARSON_BV	Location: SW
ADA ID: 82F988EDC268	Curb Cut Type: MedianRefuge2	Initial Pass/Fail: Fail	Overall Compliance: No
Severity Score: 10			
Codes/Mitigation Info/Possible Solution		Field Measurements/Component Compliance

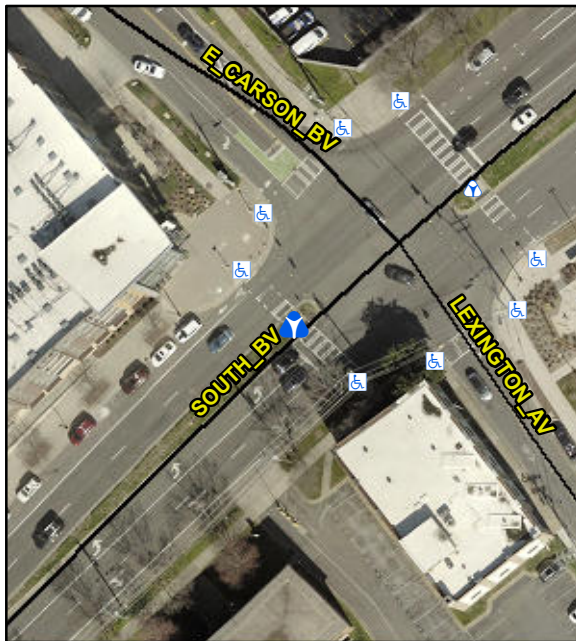
Compliance	Description	Data	Compliance	Description	Data
Yes	Refuge 1 Length (In)	54.0	N/A	Gutter 1 Ponding?	N/A
No	Refuge 1 Width (In)	54.0	N/A	Gutter 1 Lip Ht (In)	N/A
Yes	Refuge 1 Slope (%)	2.3	N/A	Gutter 1 Slope (%)	N/A
Yes	Refuge 1 X Slope (%)	2.6	N/A	Gutter 1 X Slope (%)	N/A
N/A	Painted X Walk1?	Yes	N/A	DWS 1 Provided?	N/A
N/A	X Walk 1 Direction	To NW	N/A	DWS 1 Contrast?	N/A
N/A	X Walk 1 Width (In)	113.0	N/A	DWS 1 Length (In)	N/A
N/A	Road 1 Slope (%)	2.6	N/A	DWS 1 Full Width?	N/A
N/A	Road 1 X Slope (%)	1.3	N/A	DWS 1 Offset (In)	N/A
Yes	Refuge 2 Length (In)	118.0	N/A	Gutter 2 Ponding?	N/A
Yes	Refuge 2 Width (In)	118.0	N/A	Gutter 2 Lip Ht (In)	N/A
Yes	Refuge 2 Slope (%)	4.8	N/A	Gutter 2 Slope (%)	N/A
Yes	Refuge 2 X Slope (%)	1.5	N/A	Gutter 2 X Slope (%)	N/A
N/A	Painted X Walk2?	Yes	N/A	DWS 2 Provided?	N/A
N/A	X Walk 2 Direction	To SE	N/A	DWS 2 Contrast?	N/A
N/A	X Walk 2 Width (In)	111.0	N/A	DWS 2 Length (In)	N/A

Possible Solutions:

Remove & Replace Entire Refuge.
