Access Compliance Report

Public Rights-of-Way

(Island Curb Cuts)

Intersection ID: 30454	Main Street: SHALOM_PARK_DR	Cross Street: PROVIDENCE_RD	Location: NE
ADA ID: 83867D9EE75A	Curb Cut Type: MedianRefuge2	Initial Pass/Fail: Fail	Overall Compliance: No
Severity Score: 0			
Codes/Mitigation Info/Possible Solution		Field Measurements/Component Compliance

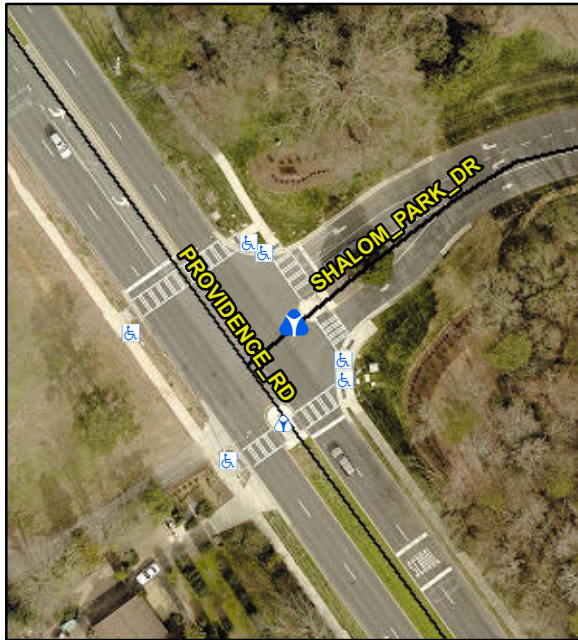
Compliance	Description	Data	Compliance	Description	Data
Yes	Refuge 1 Length (In)	79.0	N/A	Gutter 1 Ponding?	N/A
Yes	Refuge 1 Width (In)	94.0	N/A	Gutter 1 Lip Ht (In)	N/A
Yes	Refuge 1 Slope (%)	1.4	N/A	Gutter 1 Slope (%)	N/A
Yes	Refuge 1 X Slope (%)	2.9	N/A	Gutter 1 X Slope (%)	N/A
N/A	Painted X Walk1?	Yes	N/A	DWS 1 Provided?	N/A
N/A	X Walk 1 Direction	To NW	N/A	DWS 1 Contrast?	N/A
N/A	X Walk 1 Width (In)	111.0	N/A	DWS 1 Length (In)	N/A
N/A	Road 1 Slope (%)	2.5	N/A	DWS 1 Full Width?	N/A
N/A	Road 1 X Slope (%)	3.7	N/A	DWS 1 Offset (In)	N/A
Yes	Refuge 2 Length (In)	79.0	N/A	Gutter 2 Ponding?	N/A
Yes	Refuge 2 Width (In)	94.0	N/A	Gutter 2 Lip Ht (In)	N/A
Yes	Refuge 2 Slope (%)	0.3	N/A	Gutter 2 Slope (%)	N/A
Yes	Refuge 2 X Slope (%)	2.1	N/A	Gutter 2 X Slope (%)	N/A
N/A	Painted X Walk2?	Yes	N/A	DWS 2 Provided?	N/A
N/A	X Walk 2 Direction	To SE	N/A	DWS 2 Contrast?	N/A
N/A	X Walk 2 Width (In)	112.0	N/A	DWS 2 Length (In)	N/A

N/A	Road 2 Slope (%)	2.2	N/A	DWS 2 Full Width?	N/A
N/A	Road 2 X Slope (%)	2.0	N/A	DWS 2 Offset (In)	N/A
N/A	Refuge 3 Length (in)	N/A	N/A	Gutter 3 Ponding?	N/A
N/A	Refuge 3 Width (in)	N/A	N/A	Gutter 3 Lip Ht (in)	N/A
N/A	Refuge 3 Slope (%)	N/A	N/A	Gutter 3 Slope (%)	N/A
N/A	Refuge 3 XSlope (%)	N/A	N/A	Gutter 3 XSlope (%)	N/A
N/A	Painted X Walk3?	N/A	N/A	DWS 3 Provided?	N/A
N/A	X Walk 3 Direction	N/A	N/A	DWS 3 Contrast?	N/A
N/A	X Walk 3 Width (in)	N/A	N/A	DWS 3 Length (in)	N/A
N/A	Road 3 Slope (%)	N/A	N/A	DWS 3 Full Width?	N/A
N/A	Road 3 XSlope (%)	N/A	N/A	DWS 3 Offset (in)	N/A
Yes	Any Obstructions?	N/A	N/A	Storm Grate/Utility Hazard?	N/A
N/A	Obstruction Type		N/A	Storm Grate/Utility Type	
		N/A			N/A
N/A	Surface Condition	Good

Possible Solutions:

Remove & Replace Entire Refuge.
