Access Compliance Report

Public Rights-of-Way

(Island Curb Cuts)

Intersection ID: 27490	Main Street: BALLANTYNE_COMMONS_PY	Cross Street: JOHNSTON_RD	Location: NE
ADA ID: 8449D2863E5E	Curb Cut Type: IslandRefuge3	Initial Pass/Fail: Fail	Overall Compliance: No
Codes/Mitigation Info/Possible Solution		Field Measurements/Component Compliance

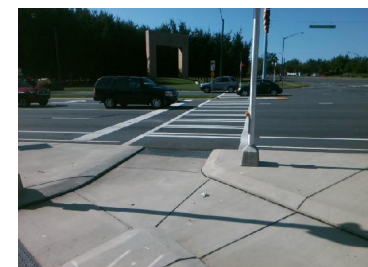
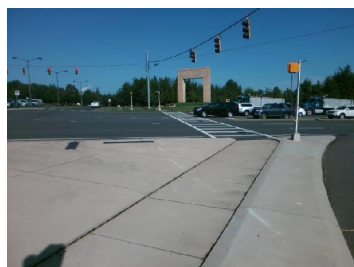
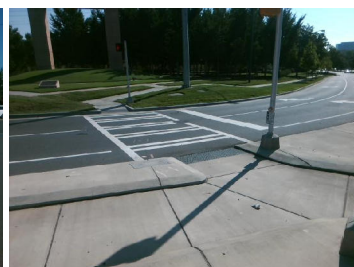
Compliance	Description	Data	Compliance	Description	Data
Yes	Refuge 1 Length (In)	60.0	N/A	Gutter 1 Ponding?	N/A
Yes	Refuge 1 Width (In)	70.0	N/A	Gutter 1 Lip Ht (In)	N/A
Yes	Refuge 1 Slope (%)	2.9	N/A	Gutter 1 Slope (%)	N/A
Yes	Refuge 1 X Slope (%)	2.1	N/A	Gutter 1 X Slope (%)	N/A
N/A	Painted X Walk1?	Yes	N/A	DWS 1 Provided?	N/A
N/A	X Walk 1 Direction	To S	N/A	DWS 1 Contrast?	N/A
N/A	X Walk 1 Width (In)	130.0	N/A	DWS 1 Length (In)	N/A
N/A	Road 1 Slope (%)	3.5	N/A	DWS 1 Full Width?	N/A
N/A	Road 1 X Slope (%)	2.1	N/A	DWS 1 Offset (In)	N/A
Yes	Refuge 2 Length (In)	27.0	N/A	Gutter 2 Ponding?	N/A
Yes	Refuge 2 Width (In)	72.0	N/A	Gutter 2 Lip Ht (In)	N/A
Yes	Refuge 2 Slope (%)	0.7	N/A	Gutter 2 Slope (%)	N/A
Yes	Refuge 2 X Slope (%)	2.5	N/A	Gutter 2 X Slope (%)	N/A
N/A	Painted X Walk2?	Yes	N/A	DWS 2 Provided?	N/A
N/A	X Walk 2 Direction	To NW	N/A	DWS 2 Contrast?	N/A
N/A	X Walk 2 Width (In)	120.0	N/A	DWS 2 Length (In)	N/A

N/A	Road 2 Slope (%)	2.1	N/A	DWS 2 Full Width?	N/A
N/A	Road 2 X Slope (%)	3.6	N/A	DWS 2 Offset (In)	N/A
Yes	Refuge 3 Length (in)	64.0	N/A	Gutter 3 Ponding?	N/A
Yes	Refuge 3 Width (in)	71.0	N/A	Gutter 3 Lip Ht (in)	N/A
Yes	Refuge 3 Slope (%)	4.6	N/A	Gutter 3 Slope (%)	N/A
Yes	Refuge 3 XSlope (%)	1.8	N/A	Gutter 3 XSlope (%)	N/A
N/A	Painted X Walk3?	Yes	N/A	DWS 3 Provided?	N/A
N/A	X Walk 3 Direction	To NE	N/A	DWS 3 Contrast?	N/A
N/A	X Walk 3 Width (in)	3.8	N/A	DWS 3 Length (in)	N/A
N/A	Road 3 Slope (%)	119.0	N/A	DWS 3 Full Width?	N/A
N/A	Road 3 XSlope (%)	1.4	N/A	DWS 3 Offset (in)	N/A
Yes	Any Obstructions?	N/A	N/A	Storm Grate/Utility Hazard?	N/A
N/A	Obstruction Type		N/A	Storm Grate/Utility Type	
		N/A			N/A
N/A	Surface Condition	Good

Remove & Replace Entire Refuge.
