# Access Compliance Report

## Public Rights-of-Way

### (Island Curb Cuts)

Intersection ID: 5967	Main Street: N_TRYON_ST	Cross Street: MCCULLOUGH_DR	Location: NW
ADA ID: 85F364EEC8D1	Curb Cut Type: MedianRefuge2	Initial Pass/Fail: Pass	Overall Compliance: No
Codes/Mitigation Info/Possible Solution		Field Measurements/Component Compliance

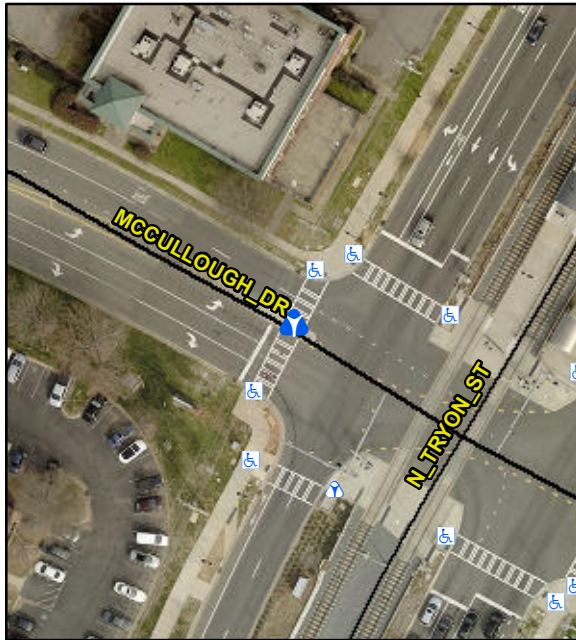
Compliance	Description	Data	Compliance	Description	Data
Yes	Refuge 1 Length (In)	41.25	Yes	Gutter 1 Ponding?	No
Yes	Refuge 1 Width (In)	119.5	No	Gutter 1 Lip Ht (In)	2.5
Yes	Refuge 1 Slope (%)	2.5	No	Gutter 1 Slope (%)	N/A
Yes	Refuge 1 X Slope (%)	0.3	No	Gutter 1 X Slope (%)	N/A
N/A	Painted X Walk1?	Yes	Yes	DWS 1 Provided?	Yes
N/A	X Walk 1 Direction	To NE	Yes	DWS 1 Contrast?	Yes
N/A	X Walk 1 Width (In)	117.5	Yes	DWS 1 Length (In)	24.0
N/A	Road 1 Slope (%)	0.4	Yes	DWS 1 Full Width?	Yes
N/A	Road 1 X Slope (%)	2.1	No	DWS 1 Offset (In)	2.5
Yes	Refuge 2 Length (In)	41.25	Yes	Gutter 2 Ponding?	No
Yes	Refuge 2 Width (In)	119.5	No	Gutter 2 Lip Ht (In)	2.0
Yes	Refuge 2 Slope (%)	2.5	No	Gutter 2 Slope (%)	N/A
Yes	Refuge 2 X Slope (%)	0.9	No	Gutter 2 X Slope (%)	N/A
N/A	Painted X Walk2?	Yes	Yes	DWS 2 Provided?	Yes
N/A	X Walk 2 Direction	To SW	Yes	DWS 2 Contrast?	Yes
N/A	X Walk 2 Width (In)	119.0	Yes	DWS 2 Length (In)	24.0

N/A	Road 2 Slope (%)	0.1	Yes	DWS 2 Full Width?	Yes
N/A	Road 2 X Slope (%)	0.2	No	DWS 2 Offset (In)	3.0
N/A	Refuge 3 Length (in)	N/A	N/A	Gutter 3 Ponding?	No
N/A	Refuge 3 Width (in)	N/A	N/A	Gutter 3 Lip Ht (in)	N/A
N/A	Refuge 3 Slope (%)	N/A	N/A	Gutter 3 Slope (%)	N/A
N/A	Refuge 3 XSlope (%)	N/A	N/A	Gutter 3 XSlope (%)	N/A
N/A	Painted X Walk3?	No	N/A	DWS 3 Provided?	N/A
N/A	X Walk 3 Direction	N/A	N/A	DWS 3 Contrast?	N/A
N/A	X Walk 3 Width (in)	N/A	N/A	DWS 3 Length (in)	N/A
N/A	Road 3 Slope (%)	N/A	N/A	DWS 3 Full Width?	N/A
N/A	Road 3 XSlope (%)	N/A	N/A	DWS 3 Offset (in)	N/A
Yes	Any Obstructions?	No	N/A	Storm Grate/Utility Hazard?	No
N/A	Obstruction Type		N/A	Storm Grate/Utility Type	
		N/A			N/A
N/A	Surface Condition	Good

**Remove & Replace Detectable Warning System. Remove & Replace Gutter.**
