Access Compliance Report

Public Rights-of-Way

(Island Curb Cuts)

Intersection ID: 53165	Main Street: DIXIE_RIVER_RD	Cross Street: STYLE_LN	Location: W
ADA ID: 860AEA2EFC9F	Curb Cut Type: MedianRefuge2	Initial Pass/Fail: Fail	Overall Compliance: No
Codes/Mitigation Info/Possible Solution		Field Measurements/Component Compliance

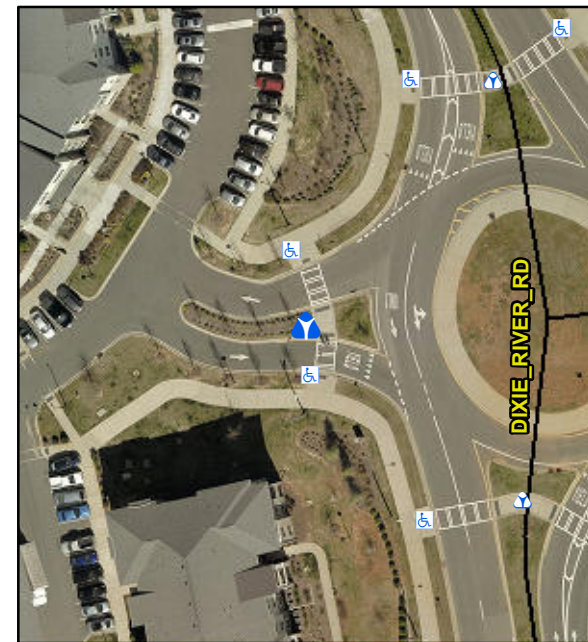
Compliance	Description	Data	Compliance	Description	Data
Yes	Refuge 1 Length (In)	94	N/A	Gutter 1 Ponding?	N/A
Yes	Refuge 1 Width (In)	115	N/A	Gutter 1 Lip Ht (In)	N/A
No	Refuge 1 Slope (%)	5.8	N/A	Gutter 1 Slope (%)	N/A
Yes	Refuge 1 X Slope (%)	2.7	N/A	Gutter 1 X Slope (%)	N/A
N/A	Painted X Walk1?	Yes	N/A	DWS 1 Provided?	N/A
N/A	X Walk 1 Direction	To S	N/A	DWS 1 Contrast?	N/A
N/A	X Walk 1 Width (In)	106	N/A	DWS 1 Length (In)	N/A
N/A	Road 1 Slope (%)	2.3	N/A	DWS 1 Full Width?	N/A
N/A	Road 1 X Slope (%)	0.6	N/A	DWS 1 Offset (In)	N/A
Yes	Refuge 2 Length (In)	94	N/A	Gutter 2 Ponding?	N/A
Yes	Refuge 2 Width (In)	115	N/A	Gutter 2 Lip Ht (In)	N/A
Yes	Refuge 2 Slope (%)	4.0	N/A	Gutter 2 Slope (%)	N/A
Yes	Refuge 2 X Slope (%)	0.1	N/A	Gutter 2 X Slope (%)	N/A
N/A	Painted X Walk2?	Yes	N/A	DWS 2 Provided?	N/A
N/A	X Walk 2 Direction	To N	N/A	DWS 2 Contrast?	N/A
N/A	X Walk 2 Width (In)	107	N/A	DWS 2 Length (In)	N/A
N/A	Road 2 Slope (%)	1.6	N/A	DWS 2 Full Width?	N/A

Possible Solutions:

Remove & Replace Entire Refuge.
