# Access Compliance Report

## Public Rights-of-Way

### (Island Curb Cuts)

Intersection ID: 10026082	Main Street: ENDAHVEN_LN	Cross Street: N/A	Location: NE
ADA ID: 86359BCC8DB5	Curb Cut Type: MedianRefuge2	Initial Pass/Fail: Pass	Overall Compliance: No
Severity Score: 0			
Codes/Mitigation Info/Possible Solution		Field Measurements/Component Compliance

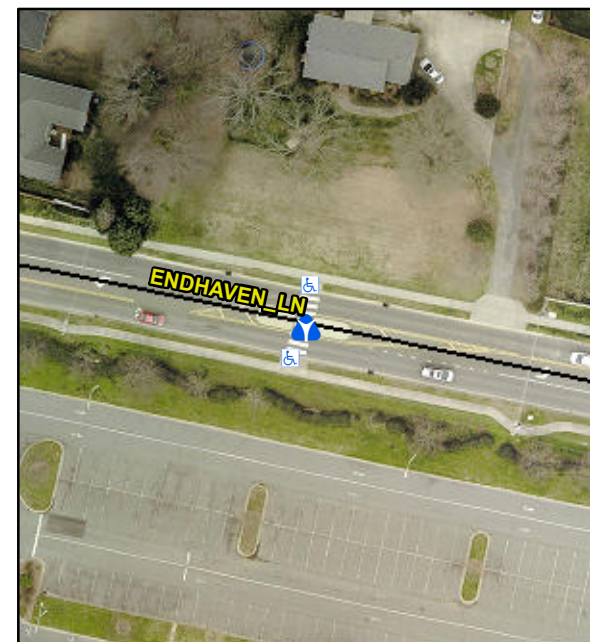
Compliance	Description	Data	Compliance	Description	Data
Yes	Refuge 1 Length (In)	53.5	Yes	Gutter 1 Ponding?	No
Yes	Refuge 1 Width (In)	119.5	Yes	Gutter 1 Lip Ht (In)	0.0
Yes	Refuge 1 Slope (%)	0.9	Yes	Gutter 1 Slope (%)	1.2
Yes	Refuge 1 X Slope (%)	0.1	Yes	Gutter 1 X Slope (%)	1.2
N/A	Painted X Walk1?	Yes	Yes	DWS 1 Provided?	Yes
N/A	X Walk 1 Direction	To SW	Yes	DWS 1 Contrast?	Yes
N/A	X Walk 1 Width (In)	121.0	Yes	DWS 1 Length (In)	24.0
N/A	Road 1 Slope (%)	1.0	Yes	DWS 1 Full Width?	Yes
N/A	Road 1 X Slope (%)	0.6	Yes	DWS 1 Offset (In)	0.0
Yes	Refuge 2 Length (In)	53.5	Yes	Gutter 2 Ponding?	No
Yes	Refuge 2 Width (In)	119.5	Yes	Gutter 2 Lip Ht (In)	0.0
Yes	Refuge 2 Slope (%)	1.2	Yes	Gutter 2 Slope (%)	2.5
Yes	Refuge 2 X Slope (%)	1.5	Yes	Gutter 2 X Slope (%)	0.6
N/A	Painted X Walk2?	Yes	Yes	DWS 2 Provided?	Yes
N/A	X Walk 2 Direction	To NE	No	DWS 2 Contrast?	N/A
N/A	X Walk 2 Width (In)	121.0	Yes	DWS 2 Length (In)	24.0

N/A	Road 2 Slope (%)	0.1	Yes	DWS 2 Full Width?	Yes
N/A	Road 2 X Slope (%)	2.0	Yes	DWS 2 Offset (In)	0.0
N/A	Refuge 3 Length (in)	N/A	N/A	Gutter 3 Ponding?	N/A
N/A	Refuge 3 Width (in)	N/A	N/A	Gutter 3 Lip Ht (in)	N/A
N/A	Refuge 3 Slope (%)	N/A	N/A	Gutter 3 Slope (%)	N/A
N/A	Refuge 3 XSlope (%)	N/A	N/A	Gutter 3 XSlope (%)	N/A
N/A	Painted X Walk3?	N/A	N/A	DWS 3 Provided?	N/A
N/A	X Walk 3 Direction	N/A	N/A	DWS 3 Contrast?	N/A
N/A	X Walk 3 Width (in)	N/A	N/A	DWS 3 Length (in)	N/A
N/A	Road 3 Slope (%)	N/A	N/A	DWS 3 Full Width?	N/A
N/A	Road 3 XSlope (%)	N/A	N/A	DWS 3 Offset (in)	N/A
Yes	Any Obstructions?	N/A	N/A	Storm Grate/Utility Hazard?	No
N/A	Obstruction Type		N/A	Storm Grate/Utility Type	
		N/A			N/A
N/A	Surface Condition	Good

**Remove & Replace Detectable Warning System.**

Total Cost: \$ 800.00
