# Access Compliance Report

## Public Rights-of-Way

### (Island Curb Cuts)

Intersection ID: 13442	Main Street: MORRIS_FIELD_DR	Cross Street: CPCC_HARRIS_CAMPUS_DR	Location: SE
ADA ID: 8654D35F9C07	Curb Cut Type: MedianRefuge2	Initial Pass/Fail: Fail	Overall Compliance: No
Codes/Mitigation Info/Possible Solution		Field Measurements/Component Compliance

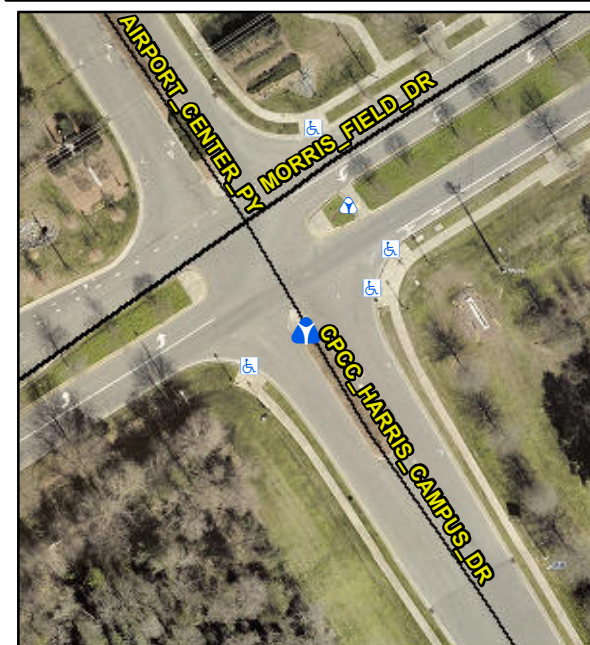
Compliance	Description	Data	Compliance	Description	Data
Yes	Refuge 1 Length (In)	56.0	N/A	Gutter 1 Ponding?	N/A
Yes	Refuge 1 Width (In)	60.0	N/A	Gutter 1 Lip Ht (In)	N/A
Yes	Refuge 1 Slope (%)	1.4	N/A	Gutter 1 Slope (%)	N/A
No	Refuge 1 X Slope (%)	8.6	N/A	Gutter 1 X Slope (%)	N/A
N/A	Painted X Walk1?	No	N/A	DWS 1 Provided?	N/A
N/A	X Walk 1 Direction	To NE	N/A	DWS 1 Contrast?	N/A
N/A	X Walk 1 Width (In)	N/A	N/A	DWS 1 Length (In)	N/A
N/A	Road 1 Slope (%)	4.4	N/A	DWS 1 Full Width?	N/A
N/A	Road 1 X Slope (%)	1.0	N/A	DWS 1 Offset (In)	N/A
Yes	Refuge 2 Length (In)	56.0	N/A	Gutter 2 Ponding?	N/A
Yes	Refuge 2 Width (In)	60.0	N/A	Gutter 2 Lip Ht (In)	N/A
Yes	Refuge 2 Slope (%)	2.0	N/A	Gutter 2 Slope (%)	N/A
No	Refuge 2 X Slope (%)	6.9	N/A	Gutter 2 X Slope (%)	N/A
N/A	Painted X Walk2?	No	N/A	DWS 2 Provided?	N/A
N/A	X Walk 2 Direction	To SW	N/A	DWS 2 Contrast?	N/A
N/A	X Walk 2 Width (In)	N/A	N/A	DWS 2 Length (In)	N/A

**Remove & Replace Entire Refuge.**
