Access Compliance Report

Public Rights-of-Way

(Island Curb Cuts)

Intersection ID: 14741	Main Street: EAST_BV	Cross Street: PARK_RD	Location: SE
ADA ID: 87333C5A4743	Curb Cut Type: MedianRefuge2	Initial Pass/Fail: Pass	Overall Compliance: No
Severity Score: 0.25			
Codes/Mitigation Info/Possible Solution		Field Measurements/Component Compliance

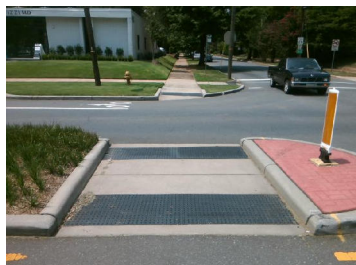
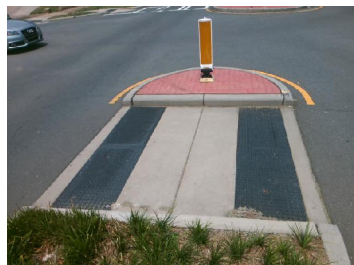
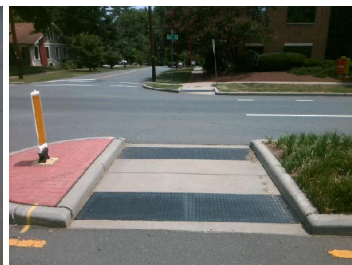
Compliance	Description	Data	Compliance	Description	Data
Yes	Refuge 1 Length (In)	54.5	Yes	Gutter 1 Ponding?	No
Yes	Refuge 1 Width (In)	97.0	Yes	Gutter 1 Lip Ht (In)	0.0
Yes	Refuge 1 Slope (%)	3.0	Yes	Gutter 1 Slope (%)	3.6
Yes	Refuge 1 X Slope (%)	0.7	Yes	Gutter 1 X Slope (%)	1.2
N/A	Painted X Walk1?	No	Yes	DWS 1 Provided?	Yes
N/A	X Walk 1 Direction	To SW	Yes	DWS 1 Contrast?	Yes
N/A	X Walk 1 Width (In)	N/A	Yes	DWS 1 Length (In)	24.5
N/A	Road 1 Slope (%)	0.9	Yes	DWS 1 Full Width?	Yes
N/A	Road 1 X Slope (%)	0.6	No	DWS 1 Offset (In)	6.5
Yes	Refuge 2 Length (In)	54.5	Yes	Gutter 2 Ponding?	No
Yes	Refuge 2 Width (In)	97.0	Yes	Gutter 2 Lip Ht (In)	0.0
Yes	Refuge 2 Slope (%)	0.7	Yes	Gutter 2 Slope (%)	1.6
Yes	Refuge 2 X Slope (%)	0.8	Yes	Gutter 2 X Slope (%)	1.1
N/A	Painted X Walk2?	No	Yes	DWS 2 Provided?	Yes
N/A	X Walk 2 Direction	To NE	Yes	DWS 2 Contrast?	Yes
N/A	X Walk 2 Width (In)	N/A	Yes	DWS 2 Length (In)	24.5

N/A	Road 2 Slope (%)	0.5	Yes	DWS 2 Full Width?	Yes
N/A	Road 2 X Slope (%)	1.8	No	DWS 2 Offset (In)	6.0
N/A	Refuge 3 Length (in)	N/A	N/A	Gutter 3 Ponding?	N/A
N/A	Refuge 3 Width (in)	N/A	N/A	Gutter 3 Lip Ht (in)	N/A
N/A	Refuge 3 Slope (%)	N/A	N/A	Gutter 3 Slope (%)	N/A
N/A	Refuge 3 XSlope (%)	N/A	N/A	Gutter 3 XSlope (%)	N/A
N/A	Painted X Walk3?	N/A	N/A	DWS 3 Provided?	N/A
N/A	X Walk 3 Direction	N/A	N/A	DWS 3 Contrast?	N/A
N/A	X Walk 3 Width (in)	N/A	N/A	DWS 3 Length (in)	N/A
N/A	Road 3 Slope (%)	N/A	N/A	DWS 3 Full Width?	N/A
N/A	Road 3 XSlope (%)	N/A	N/A	DWS 3 Offset (in)	N/A
Yes	Any Obstructions?	N/A	N/A	Storm Grate/Utility Hazard?	No
N/A	Obstruction Type		N/A	Storm Grate/Utility Type	
		N/A			N/A
N/A	Surface Condition	Good

Remove & Replace Detectable Warning System.
