Access Compliance Report

Public Rights-of-Way

(Island Curb Cuts)

Intersection ID: 19073	Main Street: GRIFFITH_RD	Cross Street: OLD_PINEVILLE_RD	Location: N
ADA ID: 873BC29D1A4F	Curb Cut Type: MedianRefuge2	Initial Pass/Fail: Fail	Overall Compliance: No
Codes/Mitigation Info/Possible Solution		Field Measurements/Component Compliance

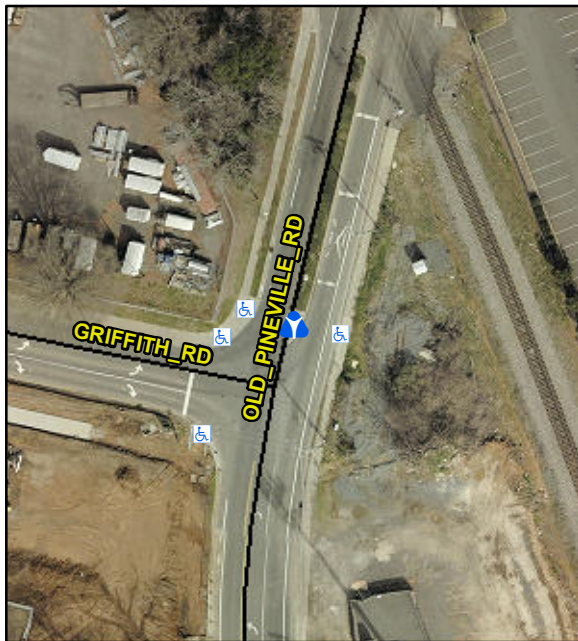
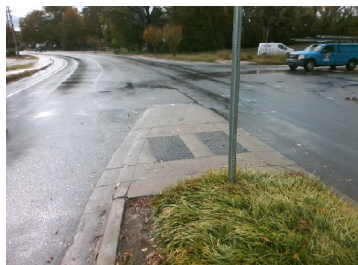
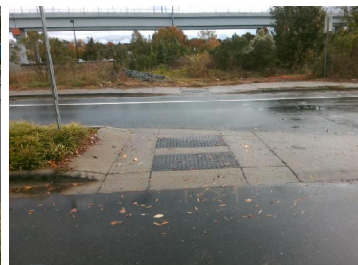
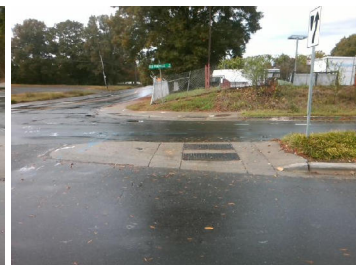
Compliance	Description	Data	Compliance	Description	Data
No	Refuge 1 Length (In)	30.5	N/A	Gutter 1 Ponding?	N/A
No	Refuge 1 Width (In)	48.0	N/A	Gutter 1 Lip Ht (In)	N/A
Yes	Refuge 1 Slope (%)	0.3	N/A	Gutter 1 Slope (%)	N/A
Yes	Refuge 1 X Slope (%)	0.2	N/A	Gutter 1 X Slope (%)	N/A
N/A	Painted X Walk1?	No	N/A	DWS 1 Provided?	N/A
N/A	X Walk 1 Direction	To W	N/A	DWS 1 Contrast?	N/A
N/A	X Walk 1 Width (In)	N/A	N/A	DWS 1 Length (In)	N/A
N/A	Road 1 Slope (%)	0.8	N/A	DWS 1 Full Width?	N/A
N/A	Road 1 X Slope (%)	0.7	N/A	DWS 1 Offset (In)	N/A
No	Refuge 2 Length (In)	30.5	N/A	Gutter 2 Ponding?	N/A
No	Refuge 2 Width (In)	48.0	N/A	Gutter 2 Lip Ht (In)	N/A
Yes	Refuge 2 Slope (%)	1.5	N/A	Gutter 2 Slope (%)	N/A
Yes	Refuge 2 X Slope (%)	0.4	N/A	Gutter 2 X Slope (%)	N/A
N/A	Painted X Walk2?	No	N/A	DWS 2 Provided?	N/A
N/A	X Walk 2 Direction	To E	N/A	DWS 2 Contrast?	N/A
N/A	X Walk 2 Width (In)	N/A	N/A	DWS 2 Length (In)	N/A
N/A	Road 2 Slope (%)	0.3	N/A	DWS 2 Full Width?	N/A

N/A	Road 2 X Slope (%)	2.1	N/A	DWS 2 Offset (In)	N/A
N/A	Refuge 3 Length (in)	N/A	N/A	Gutter 3 Ponding?	N/A
N/A	Refuge 3 Width (in)	N/A	N/A	Gutter 3 Lip Ht (in)	N/A
N/A	Refuge 3 Slope (%)	N/A	N/A	Gutter 3 Slope (%)	N/A
N/A	Refuge 3 XSlope (%)	N/A	N/A	Gutter 3 XSlope (%)	N/A
N/A	Painted X Walk3?	N/A	N/A	DWS 3 Provided?	N/A
N/A	X Walk 3 Direction	N/A	N/A	DWS 3 Contrast?	N/A
N/A	X Walk 3 Width (in)	N/A	N/A	DWS 3 Length (in)	N/A
N/A	Road 3 Slope (%)	N/A	N/A	DWS 3 Full Width?	N/A
N/A	Road 3 XSlope (%)	N/A	N/A	DWS 3 Offset (in)	N/A
Yes	Any Obstructions?	N/A	N/A	Storm Grate/Utility Hazard?	N/A
N/A	Obstruction Type		N/A	Storm Grate/Utility Type	
		N/A			N/A
N/A	Surface Condition	Good

Remove & Replace Entire Refuge.
