Access Compliance Report

Public Rights-of-Way

(Island Curb Cuts)

Intersection ID: 10034318	Main Street: PERIMETER_POINTE_PY	Cross Street: N/A	Location: E
ADA ID: 880828EB8F64	Curb Cut Type: MedianRefuge2	Initial Pass/Fail: Fail	Overall Compliance: No
Severity Score: 10			
Codes/Mitigation Info/Possible Solution		Field Measurements/Component Compliance

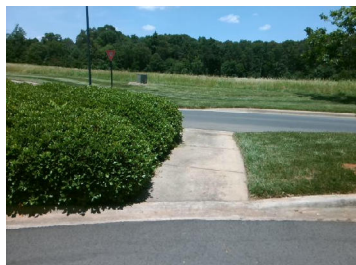
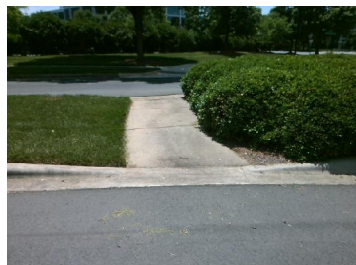
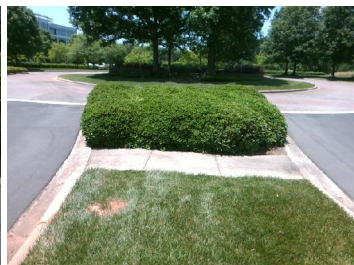
Compliance	Description	Data	Compliance	Description	Data
Yes	Refuge 1 Length (In)	77.5	N/A	Gutter 1 Ponding?	N/A
No	Refuge 1 Width (In)	59.0	N/A	Gutter 1 Lip Ht (In)	N/A
Yes	Refuge 1 Slope (%)	1.9	N/A	Gutter 1 Slope (%)	N/A
Yes	Refuge 1 X Slope (%)	2.2	N/A	Gutter 1 X Slope (%)	N/A
N/A	Painted X Walk1?	No	N/A	DWS 1 Provided?	N/A
N/A	X Walk 1 Direction	To S	N/A	DWS 1 Contrast?	N/A
N/A	X Walk 1 Width (In)	N/A	N/A	DWS 1 Length (In)	N/A
N/A	Road 1 Slope (%)	2.0	N/A	DWS 1 Full Width?	N/A
N/A	Road 1 X Slope (%)	2.2	N/A	DWS 1 Offset (In)	N/A
Yes	Refuge 2 Length (In)	77.5	N/A	Gutter 2 Ponding?	N/A
No	Refuge 2 Width (In)	59.0	N/A	Gutter 2 Lip Ht (In)	N/A
Yes	Refuge 2 Slope (%)	2.9	N/A	Gutter 2 Slope (%)	N/A
Yes	Refuge 2 X Slope (%)	0.9	N/A	Gutter 2 X Slope (%)	N/A
N/A	Painted X Walk2?	No	N/A	DWS 2 Provided?	N/A
N/A	X Walk 2 Direction	To N	N/A	DWS 2 Contrast?	N/A
N/A	X Walk 2 Width (In)	N/A	N/A	DWS 2 Length (In)	N/A

N/A	Road 2 Slope (%)	2.8	N/A	DWS 2 Full Width?	N/A
N/A	Road 2 X Slope (%)	1.5	N/A	DWS 2 Offset (In)	N/A
N/A	Refuge 3 Length (in)	N/A	N/A	Gutter 3 Ponding?	N/A
N/A	Refuge 3 Width (in)	N/A	N/A	Gutter 3 Lip Ht (in)	N/A
N/A	Refuge 3 Slope (%)	N/A	N/A	Gutter 3 Slope (%)	N/A
N/A	Refuge 3 XSlope (%)	N/A	N/A	Gutter 3 XSlope (%)	N/A
N/A	Painted X Walk3?	N/A	N/A	DWS 3 Provided?	N/A
N/A	X Walk 3 Direction	N/A	N/A	DWS 3 Contrast?	N/A
N/A	X Walk 3 Width (in)	N/A	N/A	DWS 3 Length (in)	N/A
N/A	Road 3 Slope (%)	N/A	N/A	DWS 3 Full Width?	N/A
N/A	Road 3 XSlope (%)	N/A	N/A	DWS 3 Offset (in)	N/A
Yes	Any Obstructions?	N/A	N/A	Storm Grate/Utility Hazard?	N/A
N/A	Obstruction Type		N/A	Storm Grate/Utility Type	
		N/A			N/A
N/A	Surface Condition	Good

Possible Solutions:

Remove & Replace Entire Refuge.

\$ 3000.00
