Access Compliance Report

Public Rights-of-Way

(Island Curb Cuts)

Intersection ID: 18026	Main Street: E_INDEPENDENCE_BV	Cross Street: WALLACE_LN	Location: W
ADA ID: 892596C372F6	Curb Cut Type: MedianRefuge2	Initial Pass/Fail: Pass	Overall Compliance: No
Codes/Mitigation Info/Possible Solution		Field Measurements/Component Compliance	
Severity Score: 15

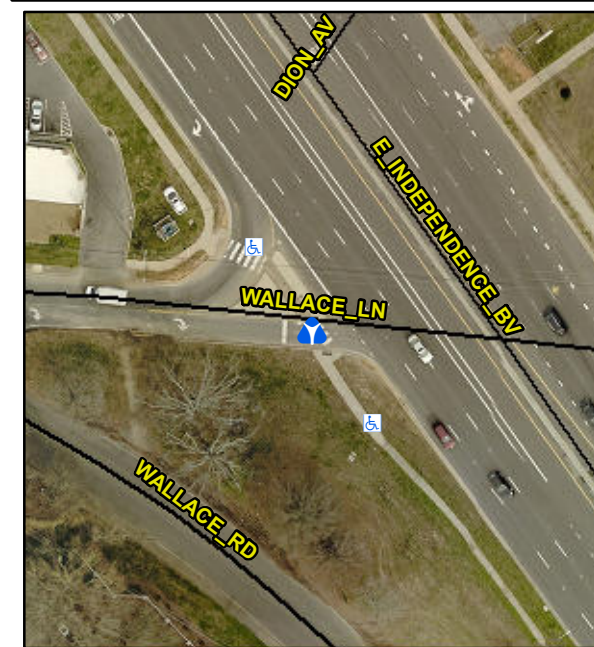
Compliance	Description	Data	Compliance	Description	Data
Yes	Refuge 1 Length (In)	183.0	Yes	Gutter 1 Ponding?	No
Yes	Refuge 1 Width (In)	71.0	Yes	Gutter 1 Lip Ht (In)	0.0
Yes	Refuge 1 Slope (%)	0.2	Yes	Gutter 1 Slope (%)	1.3
Yes	Refuge 1 X Slope (%)	1.6	Yes	Gutter 1 X Slope (%)	0.4
N/A	Painted X Walk1?	Yes	No	DWS 1 Provided?	No
N/A	X Walk 1 Direction	To NW	N/A	DWS 1 Contrast?	N/A
N/A	X Walk 1 Width (In)	122.0	N/A	DWS 1 Length (In)	N/A
N/A	Road 1 Slope (%)	0.8	N/A	DWS 1 Full Width?	N/A
N/A	Road 1 X Slope (%)	1.1	N/A	DWS 1 Offset (In)	N/A
Yes	Refuge 2 Length (In)	183.0	Yes	Gutter 2 Ponding?	No
Yes	Refuge 2 Width (In)	71.0	Yes	Gutter 2 Lip Ht (In)	0.0
Yes	Refuge 2 Slope (%)	0.6	Yes	Gutter 2 Slope (%)	0.9
Yes	Refuge 2 X Slope (%)	0.0	Yes	Gutter 2 X Slope (%)	0.7
N/A	Painted X Walk2?	Yes	No	DWS 2 Provided?	No
N/A	X Walk 2 Direction	To SE	N/A	DWS 2 Contrast?	N/A
N/A	X Walk 2 Width (In)	96.0	N/A	DWS 2 Length (In)	N/A

N/A	Road 2 Slope (%)	0.6	N/A	DWS 2 Full Width?	N/A
N/A	Road 2 X Slope (%)	1.2	N/A	DWS 2 Offset (In)	N/A
N/A	Refuge 3 Length (in)	N/A	N/A	Gutter 3 Ponding?	N/A
N/A	Refuge 3 Width (in)	N/A	N/A	Gutter 3 Lip Ht (in)	N/A
N/A	Refuge 3 Slope (%)	N/A	N/A	Gutter 3 Slope (%)	N/A
N/A	Refuge 3 XSlope (%)	N/A	N/A	Gutter 3 XSlope (%)	N/A
N/A	Painted X Walk3?	N/A	N/A	DWS 3 Provided?	N/A
N/A	X Walk 3 Direction	N/A	N/A	DWS 3 Contrast?	N/A
N/A	X Walk 3 Width (in)	N/A	N/A	DWS 3 Length (in)	N/A
N/A	Road 3 Slope (%)	N/A	N/A	DWS 3 Full Width?	N/A
N/A	Road 3 XSlope (%)	N/A	N/A	DWS 3 Offset (in)	N/A
Yes	Any Obstructions?	N/A	N/A	Storm Grate/Utility Hazard?	No
N/A	Obstruction Type		N/A	Storm Grate/Utility Type	
		N/A			N/A
N/A	Surface Condition	Good

Possible Solutions:

Install Detectable Warning System.

Total Cost: \$ 470.00
