Access Compliance Report

Public Rights-of-Way

(Island Curb Cuts)

Intersection ID: 7486	Main Street: N_TRYON_ST	Cross Street: OWEN_BV	Location:	N
ADA ID: 8A771A06A96A	Curb Cut Type: MedianRefuge2	Initial Pass/Fail: Pass	Overall Compliance: No	Severity Score: 0
Codes/Mitigation Info/Possible Solution		Field Measurements/Component Compliance

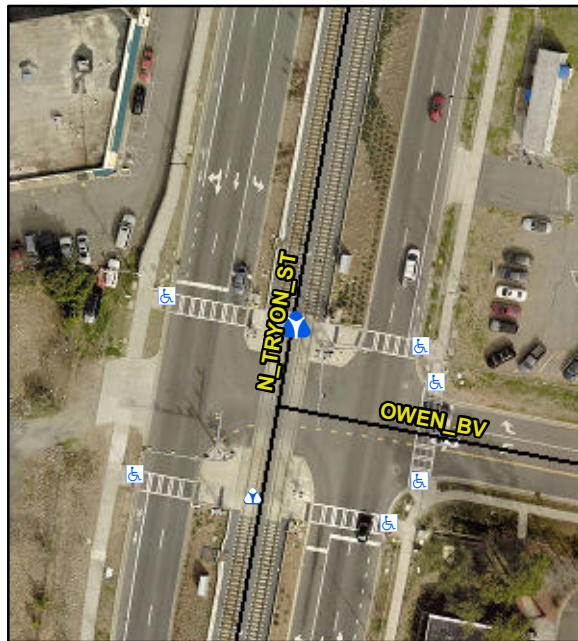
Compliance	Description	Data	Compliance	Description	Data
Yes	Refuge 1 Length (In)	105.0	Yes	Gutter 1 Ponding?	No
Yes	Refuge 1 Width (In)	107.0	Yes	Gutter 1 Lip Ht (In)	0.0
Yes	Refuge 1 Slope (%)	0.8	Yes	Gutter 1 Slope (%)	2.1
Yes	Refuge 1 X Slope (%)	0.6	Yes	Gutter 1 X Slope (%)	0.5
N/A	Painted X Walk1?	Yes	Yes	DWS 1 Provided?	Yes
N/A	X Walk 1 Direction	To E	Yes	DWS 1 Contrast?	Yes
N/A	X Walk 1 Width (In)	105.0	Yes	DWS 1 Length (In)	24.0
N/A	Road 1 Slope (%)	0.4	Yes	DWS 1 Full Width?	Yes
N/A	Road 1 X Slope (%)	2.6	No	DWS 1 Offset (In)	4.5
Yes	Refuge 2 Length (In)	105.0	Yes	Gutter 2 Ponding?	No
Yes	Refuge 2 Width (In)	107.0	No	Gutter 2 Lip Ht (In)	0.2
Yes	Refuge 2 Slope (%)	0.8	Yes	Gutter 2 Slope (%)	2.4
Yes	Refuge 2 X Slope (%)	0.2	Yes	Gutter 2 X Slope (%)	0.4
N/A	Painted X Walk2?	No	Yes	DWS 2 Provided?	Yes
N/A	X Walk 2 Direction	To W	Yes	DWS 2 Contrast?	Yes
N/A	X Walk 2 Width (In)	N/A	Yes	DWS 2 Length (In)	24.0

N/A	Road 2 Slope (%)	0.3	Yes	DWS 2 Full Width?	Yes
N/A	Road 2 X Slope (%)	0.5	No	DWS 2 Offset (In)	52.0
N/A	Refuge 3 Length (in)	N/A	N/A	Gutter 3 Ponding?	N/A
N/A	Refuge 3 Width (in)	N/A	N/A	Gutter 3 Lip Ht (in)	N/A
N/A	Refuge 3 Slope (%)	N/A	N/A	Gutter 3 Slope (%)	N/A
N/A	Refuge 3 XSlope (%)	N/A	N/A	Gutter 3 XSlope (%)	N/A
N/A	Painted X Walk3?	N/A	N/A	DWS 3 Provided?	N/A
N/A	X Walk 3 Direction	N/A	N/A	DWS 3 Contrast?	N/A
N/A	X Walk 3 Width (in)	N/A	N/A	DWS 3 Length (in)	N/A
N/A	Road 3 Slope (%)	N/A	N/A	DWS 3 Full Width?	N/A
N/A	Road 3 XSlope (%)	N/A	N/A	DWS 3 Offset (in)	N/A
Yes	Any Obstructions?	N/A	N/A	Storm Grate/Utility Hazard?	No
N/A	Obstruction Type		N/A	Storm Grate/Utility Type	
		N/A			N/A
N/A	Surface Condition	Good

Remove & Replace Detectable Warning System. Grind Gutter Lip.
