Access Compliance Report Public Rights-of-Way (Island Curb Cuts)

Intersection ID: 10025574	Main Street: E_W_T_HARRIS_BV	Cross Street: N/A	Location: NW
ADA ID: 8AC04AA51D3F	Curb Cut Type: MedianRefuge2	Initial Pass/Fail: Fail	Overall Compliance: No
Severity Score: 0			
Codes/Mitigation Info/Possible Solution		Field Measurements/Component Compliance

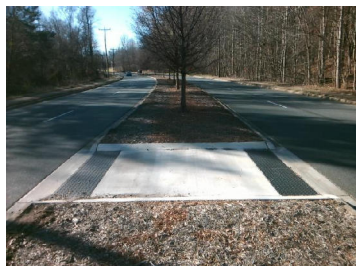
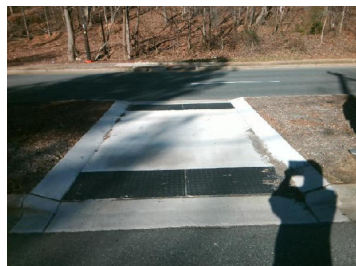
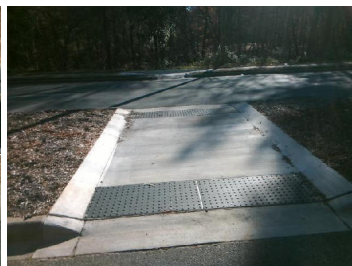
Compliance	Description	Data	Compliance	Description	Data
Yes	Refuge 1 Length (In)	83.25	N/A	Gutter 1 Ponding?	N/A
Yes	Refuge 1 Width (In)	99.0	N/A	Gutter 1 Lip Ht (In)	N/A
Yes	Refuge 1 Slope (%)	0.8	N/A	Gutter 1 Slope (%)	N/A
Yes	Refuge 1 X Slope (%)	1.6	N/A	Gutter 1 X Slope (%)	N/A
N/A	Painted X Walk1?	No	N/A	DWS 1 Provided?	N/A
N/A	X Walk 1 Direction	To NW	N/A	DWS 1 Contrast?	N/A
N/A	X Walk 1 Width (In)	N/A	N/A	DWS 1 Length (In)	N/A
N/A	Road 1 Slope (%)	1.5	N/A	DWS 1 Full Width?	N/A
N/A	Road 1 X Slope (%)	2.3	N/A	DWS 1 Offset (In)	N/A
Yes	Refuge 2 Length (In)	83.25	N/A	Gutter 2 Ponding?	N/A
Yes	Refuge 2 Width (In)	99.0	N/A	Gutter 2 Lip Ht (In)	N/A
Yes	Refuge 2 Slope (%)	1.6	N/A	Gutter 2 Slope (%)	N/A
Yes	Refuge 2 X Slope (%)	2.4	N/A	Gutter 2 X Slope (%)	N/A
N/A	Painted X Walk2?	No	N/A	DWS 2 Provided?	N/A
N/A	X Walk 2 Direction	To SE	N/A	DWS 2 Contrast?	N/A
N/A	X Walk 2 Width (In)	N/A	N/A	DWS 2 Length (In)	N/A

N/A	Road 2 Slope (%)	0.3	N/A	DWS 2 Full Width?	N/A
N/A	Road 2 X Slope (%)	2.4	N/A	DWS 2 Offset (In)	N/A
N/A	Refuge 3 Length (in)	N/A	N/A	Gutter 3 Ponding?	N/A
N/A	Refuge 3 Width (in)	N/A	N/A	Gutter 3 Lip Ht (in)	N/A
N/A	Refuge 3 Slope (%)	N/A	N/A	Gutter 3 Slope (%)	N/A
N/A	Refuge 3 XSlope (%)	N/A	N/A	Gutter 3 XSlope (%)	N/A
N/A	Painted X Walk3?	N/A	N/A	DWS 3 Provided?	N/A
N/A	X Walk 3 Direction	N/A	N/A	DWS 3 Contrast?	N/A
N/A	X Walk 3 Width (in)	N/A	N/A	DWS 3 Length (in)	N/A
N/A	Road 3 Slope (%)	N/A	N/A	DWS 3 Full Width?	N/A
N/A	Road 3 XSlope (%)	N/A	N/A	DWS 3 Offset (in)	N/A
Yes	Any Obstructions?	N/A	N/A	Storm Grate/Utility Hazard?	N/A
N/A	Obstruction Type		N/A	Storm Grate/Utility Type	
		N/A			N/A
N/A	Surface Condition	Good

Remove & Replace Entire Refuge.
