# Access Compliance Report

## Public Rights-of-Way

### (Island Curb Cuts)

Intersection ID: 11322	Main Street: N_GRAHAM_ST	Cross Street: W_10TH_ST	Location:	E
ADA ID: 8B029BD8673D	Curb Cut Type: IslandRefuge2	Initial Pass/Fail: Pass	Overall Compliance: No	Severity Score: 0

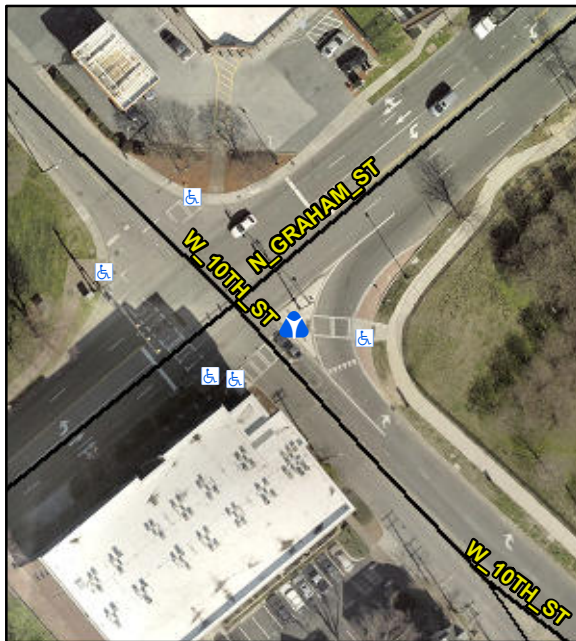
Compliance	Description	Data	Compliance	Description	Data
Yes	Refuge 1 Length (In)	53.0	Yes	Gutter 1 Ponding?	No
Yes	Refuge 1 Width (In)	73.0	Yes	Gutter 1 Lip Ht (In)	0.0
Yes	Refuge 1 Slope (%)	0.3	Yes	Gutter 1 Slope (%)	2.1
Yes	Refuge 1 X Slope (%)	1.6	Yes	Gutter 1 X Slope (%)	0.9
N/A	Painted X Walk1?	Yes	Yes	DWS 1 Provided?	Yes
N/A	X Walk 1 Direction	To E	Yes	DWS 1 Contrast?	Yes
N/A	X Walk 1 Width (In)	110.0	Yes	DWS 1 Length (In)	24.0
N/A	Road 1 Slope (%)	2.4	Yes	DWS 1 Full Width?	Yes
N/A	Road 1 X Slope (%)	1.4	No	DWS 1 Offset (In)	10.0
Yes	Refuge 2 Length (In)	64.0	Yes	Gutter 2 Ponding?	No
Yes	Refuge 2 Width (In)	73.0	Yes	Gutter 2 Lip Ht (In)	0.0
Yes	Refuge 2 Slope (%)	0.9	Yes	Gutter 2 Slope (%)	1.9
Yes	Refuge 2 X Slope (%)	1.8	No	Gutter 2 X Slope (%)	5.2
N/A	Painted X Walk2?	Yes	Yes	DWS 2 Provided?	Yes
N/A	X Walk 2 Direction	To SW	Yes	DWS 2 Contrast?	Yes
N/A	X Walk 2 Width (In)	110.0	Yes	DWS 2 Length (In)	24.0

N/A	Road 2 Slope (%)	3.4	Yes	DWS 2 Full Width?	Yes
N/A	Road 2 X Slope (%)	0.2	No	DWS 2 Offset (In)	12.0
N/A	Refuge 3 Length (in)	N/A	N/A	Gutter 3 Ponding?	N/A
N/A	Refuge 3 Width (in)	N/A	N/A	Gutter 3 Lip Ht (in)	N/A
N/A	Refuge 3 Slope (%)	N/A	N/A	Gutter 3 Slope (%)	N/A
N/A	Refuge 3 XSlope (%)	N/A	N/A	Gutter 3 XSlope (%)	N/A
N/A	Painted X Walk3?	N/A	N/A	DWS 3 Provided?	N/A
N/A	X Walk 3 Direction	N/A	N/A	DWS 3 Contrast?	N/A
N/A	X Walk 3 Width (in)	N/A	N/A	DWS 3 Length (in)	N/A
N/A	Road 3 Slope (%)	N/A	N/A	DWS 3 Full Width?	N/A
N/A	Road 3 XSlope (%)	N/A	N/A	DWS 3 Offset (in)	N/A
Yes	Any Obstructions?	N/A	N/A	Storm Grate/Utility Hazard?	No
N/A	Obstruction Type		N/A	Storm Grate/Utility Type	
N/A	Surface Condition	Good			N/A

**Remove & Replace Detectable Warning System. Remove & Replace Gutter.**
