Access Compliance Report

Public Rights-of-Way

(Island Curb Cuts)

Intersection ID: 48160	Main Street: NORTHLAKE CENTRE PY	Cross Street: N/A	Location: NE
ADA ID: 8B0DACBE0ED9	Curb Cut Type: MedianRefuge2	Initial Pass/Fail: Fail	Overall Compliance: No
Severity Score: 1.25			
Codes/Mitigation Info/Possible Solution		Field Measurements/Component Compliance

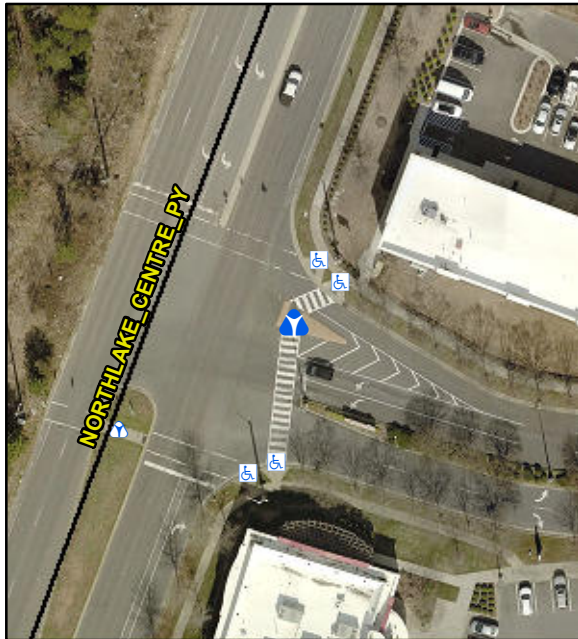
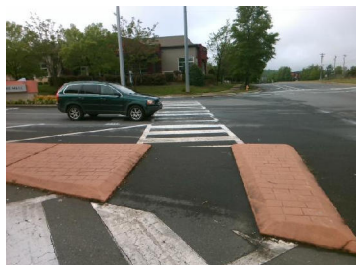
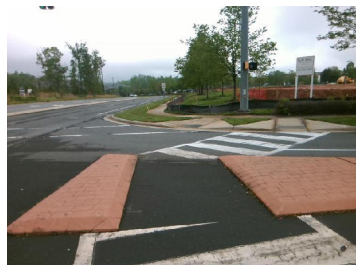
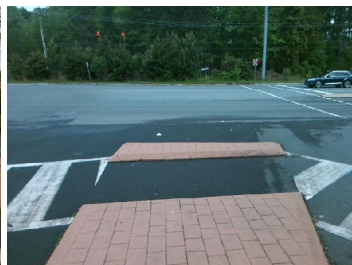
Compliance	Description	Data	Compliance	Description	Data
Yes	Refuge 1 Length (In)	68.0	N/A	Gutter 1 Ponding?	N/A
Yes	Refuge 1 Width (In)	83.0	N/A	Gutter 1 Lip Ht (In)	N/A
Yes	Refuge 1 Slope (%)	2.2	N/A	Gutter 1 Slope (%)	N/A
Yes	Refuge 1 X Slope (%)	1.4	N/A	Gutter 1 X Slope (%)	N/A
N/A	Painted X Walk1?	Yes	N/A	DWS 1 Provided?	N/A
N/A	X Walk 1 Direction	To S	N/A	DWS 1 Contrast?	N/A
N/A	X Walk 1 Width (In)	104.0	N/A	DWS 1 Length (In)	N/A
N/A	Road 1 Slope (%)	1.9	N/A	DWS 1 Full Width?	N/A
N/A	Road 1 X Slope (%)	0.6	N/A	DWS 1 Offset (In)	N/A
Yes	Refuge 2 Length (In)	68.0	N/A	Gutter 2 Ponding?	N/A
Yes	Refuge 2 Width (In)	83.0	N/A	Gutter 2 Lip Ht (In)	N/A
Yes	Refuge 2 Slope (%)	1.2	N/A	Gutter 2 Slope (%)	N/A
Yes	Refuge 2 X Slope (%)	2.8	N/A	Gutter 2 X Slope (%)	N/A
N/A	Painted X Walk2?	Yes	N/A	DWS 2 Provided?	N/A
N/A	X Walk 2 Direction	To NE	N/A	DWS 2 Contrast?	N/A
N/A	X Walk 2 Width (In)	104.0	N/A	DWS 2 Length (In)	N/A

N/A	Road 2 Slope (%)	2.5	N/A	DWS 2 Full Width?	N/A
N/A	Road 2 X Slope (%)	1.4	N/A	DWS 2 Offset (In)	N/A
N/A	Refuge 3 Length (in)	N/A	N/A	Gutter 3 Ponding?	N/A
N/A	Refuge 3 Width (in)	N/A	N/A	Gutter 3 Lip Ht (in)	N/A
N/A	Refuge 3 Slope (%)	N/A	N/A	Gutter 3 Slope (%)	N/A
N/A	Refuge 3 XSlope (%)	N/A	N/A	Gutter 3 XSlope (%)	N/A
N/A	Painted X Walk3?	N/A	N/A	DWS 3 Provided?	N/A
N/A	X Walk 3 Direction	N/A	N/A	DWS 3 Contrast?	N/A
N/A	X Walk 3 Width (in)	N/A	N/A	DWS 3 Length (in)	N/A
N/A	Road 3 Slope (%)	N/A	N/A	DWS 3 Full Width?	N/A
N/A	Road 3 XSlope (%)	N/A	N/A	DWS 3 Offset (in)	N/A
Yes	Any Obstructions?	N/A	N/A	Storm Grate/Utility Hazard?	N/A
N/A	Obstruction Type		N/A	Storm Grate/Utility Type	
		N/A			N/A
N/A	Surface Condition	Good

Remove & Replace Entire Refuge.
