Access Compliance Report

Public Rights-of-Way

(Island Curb Cuts)

Intersection ID: 5117	Main Street: SPECTOR_DR	Cross Street: STATESVILLE_RD	Location: N
ADA ID: 8B2BFB77C0BF	Curb Cut Type: MedianRefuge2	Initial Pass/Fail: Fail	Overall Compliance: No
Severity Score: 1.25			
Codes/Mitigation Info/Possible Solution		Field Measurements/Component Compliance

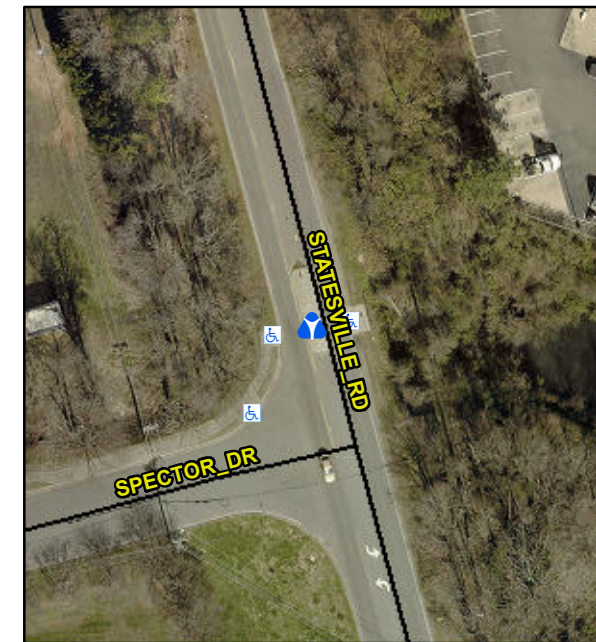
Compliance	Description	Data	Compliance	Description	Data
Yes	Refuge 1 Length (In)	60.0	N/A	Gutter 1 Ponding?	N/A
Yes	Refuge 1 Width (In)	108.0	N/A	Gutter 1 Lip Ht (In)	N/A
Yes	Refuge 1 Slope (%)	3.0	N/A	Gutter 1 Slope (%)	N/A
Yes	Refuge 1 X Slope (%)	0.7	N/A	Gutter 1 X Slope (%)	N/A
N/A	Painted X Walk1?	No	N/A	DWS 1 Provided?	N/A
N/A	X Walk 1 Direction	To W	N/A	DWS 1 Contrast?	N/A
N/A	X Walk 1 Width (In)	N/A	N/A	DWS 1 Length (In)	N/A
N/A	Road 1 Slope (%)	0.2	N/A	DWS 1 Full Width?	N/A
N/A	Road 1 X Slope (%)	4.1	N/A	DWS 1 Offset (In)	N/A
Yes	Refuge 2 Length (In)	60.0	N/A	Gutter 2 Ponding?	N/A
Yes	Refuge 2 Width (In)	108.0	N/A	Gutter 2 Lip Ht (In)	N/A
Yes	Refuge 2 Slope (%)	0.2	N/A	Gutter 2 Slope (%)	N/A
Yes	Refuge 2 X Slope (%)	1.7	N/A	Gutter 2 X Slope (%)	N/A
N/A	Painted X Walk2?	No	N/A	DWS 2 Provided?	N/A
N/A	X Walk 2 Direction	To E	N/A	DWS 2 Contrast?	N/A
N/A	X Walk 2 Width (In)	N/A	N/A	DWS 2 Length (In)	N/A

N/A	Road 2 Slope (%)	0.7	N/A	DWS 2 Full Width?	N/A
N/A	Road 2 X Slope (%)	4.1	N/A	DWS 2 Offset (In)	N/A
N/A	Refuge 3 Length (in)	N/A	N/A	Gutter 3 Ponding?	N/A
N/A	Refuge 3 Width (in)	N/A	N/A	Gutter 3 Lip Ht (in)	N/A
N/A	Refuge 3 Slope (%)	N/A	N/A	Gutter 3 Slope (%)	N/A
N/A	Refuge 3 XSlope (%)	N/A	N/A	Gutter 3 XSlope (%)	N/A
N/A	Painted X Walk3?	No	N/A	DWS 3 Provided?	N/A
N/A	X Walk 3 Direction	N/A	N/A	DWS 3 Contrast?	N/A
N/A	X Walk 3 Width (in)	N/A	N/A	DWS 3 Length (in)	N/A
N/A	Road 3 Slope (%)	N/A	N/A	DWS 3 Full Width?	N/A
N/A	Road 3 XSlope (%)	N/A	N/A	DWS 3 Offset (in)	N/A
Yes	Any Obstructions?	N/A	N/A	Storm Grate/Utility Hazard?	N/A
N/A	Obstruction Type		N/A	Storm Grate/Utility Type	
			N/A		N/A
N/A	Surface Condition	Good

Remove & Replace Entire Refuge.

\$ 3000.00
