Access Compliance Report

Public Rights-of-Way

(Island Curb Cuts)

Intersection ID: 9648	Main Street: TIMBERBROOK_DR	Cross Street: TUCKASEEGEE_RD	Location: SW
ADA ID: 8BEC45301BA9	Curb Cut Type: MedianRefuge2	Initial Pass/Fail: Fail	Overall Compliance: No
Severity Score: 12.5			
Codes/Mitigation Info/Possible Solution		Field Measurements/Component Compliance

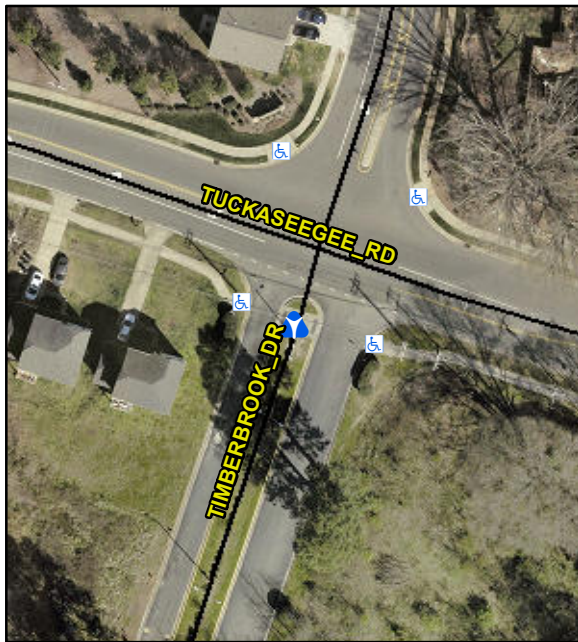
Compliance	Description	Data	Compliance	Description	Data
Yes	Refuge 1 Length (In)	115.0	N/A	Gutter 1 Ponding?	N/A
Yes	Refuge 1 Width (In)	144.0	N/A	Gutter 1 Lip Ht (In)	N/A
Yes	Refuge 1 Slope (%)	0.9	N/A	Gutter 1 Slope (%)	N/A
No	Refuge 1 X Slope (%)	6.5	N/A	Gutter 1 X Slope (%)	N/A
N/A	Painted X Walk1?	No	N/A	DWS 1 Provided?	N/A
N/A	X Walk 1 Direction	To SW	N/A	DWS 1 Contrast?	N/A
N/A	X Walk 1 Width (In)	N/A	N/A	DWS 1 Length (In)	N/A
N/A	Road 1 Slope (%)	4.3	N/A	DWS 1 Full Width?	N/A
N/A	Road 1 X Slope (%)	5.1	N/A	DWS 1 Offset (In)	N/A
Yes	Refuge 2 Length (In)	115.0	N/A	Gutter 2 Ponding?	N/A
Yes	Refuge 2 Width (In)	144.0	N/A	Gutter 2 Lip Ht (In)	N/A
Yes	Refuge 2 Slope (%)	2.0	N/A	Gutter 2 Slope (%)	N/A
No	Refuge 2 X Slope (%)	6.3	N/A	Gutter 2 X Slope (%)	N/A
N/A	Painted X Walk2?	No	N/A	DWS 2 Provided?	N/A
N/A	X Walk 2 Direction	To W	N/A	DWS 2 Contrast?	N/A
N/A	X Walk 2 Width (In)	N/A	N/A	DWS 2 Length (In)	N/A

Remove & Replace Entire Refuge.
