Access Compliance Report

Public Rights-of-Way

(Island Curb Cuts)

Intersection ID: 9925	Main Street: TENNYSON_DR	Cross Street: TUCKASEEGEE_RD	Location: S
ADA ID: 8C9AE060EC57	Curb Cut Type: MedianRefuge2	Initial Pass/Fail: Pass	Overall Compliance: No
Codes/Mitigation Info/Possible Solution		Field Measurements/Component Compliance	
Severity Score: 5.25

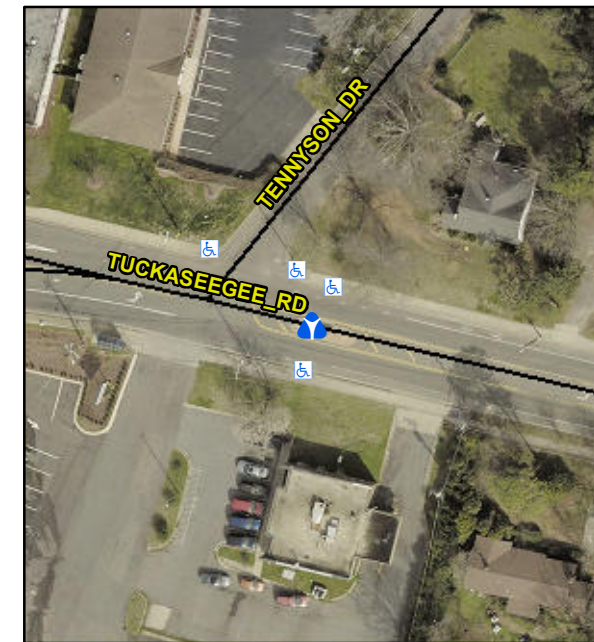
Compliance	Description	Data	Compliance	Description	Data
Yes	Refuge 1 Length (In)	59.0	Yes	Gutter 1 Ponding?	No
Yes	Refuge 1 Width (In)	112.0	Yes	Gutter 1 Lip Ht (In)	0.0
Yes	Refuge 1 Slope (%)	4.8	Yes	Gutter 1 Slope (%)	4.3
Yes	Refuge 1 X Slope (%)	1.5	Yes	Gutter 1 X Slope (%)	1.7
N/A	Painted X Walk1?	No	Yes	DWS 1 Provided?	Yes
N/A	X Walk 1 Direction	To S	Yes	DWS 1 Contrast?	Yes
N/A	X Walk 1 Width (In)	N/A	Yes	DWS 1 Length (In)	24.5
N/A	Road 1 Slope (%)	2.1	No	DWS 1 Full Width?	No
N/A	Road 1 X Slope (%)	3.9	Yes	DWS 1 Offset (In)	1.5
Yes	Refuge 2 Length (In)	59.0	Yes	Gutter 2 Ponding?	No
Yes	Refuge 2 Width (In)	112.0	Yes	Gutter 2 Lip Ht (In)	0.0
Yes	Refuge 2 Slope (%)	4.4	Yes	Gutter 2 Slope (%)	0.9
Yes	Refuge 2 X Slope (%)	1.4	Yes	Gutter 2 X Slope (%)	1.4
N/A	Painted X Walk2?	No	Yes	DWS 2 Provided?	Yes
N/A	X Walk 2 Direction	To N	Yes	DWS 2 Contrast?	Yes
N/A	X Walk 2 Width (In)	N/A	Yes	DWS 2 Length (In)	24.5

N/A	Road 2 Slope (%)	1.8	No	DWS 2 Full Width?	No
N/A	Road 2 X Slope (%)	2.3	Yes	DWS 2 Offset (In)	1.5
N/A	Refuge 3 Length (in)	N/A	N/A	Gutter 3 Ponding?	N/A
N/A	Refuge 3 Width (in)	N/A	N/A	Gutter 3 Lip Ht (in)	N/A
N/A	Refuge 3 Slope (%)	N/A	N/A	Gutter 3 Slope (%)	N/A
N/A	Refuge 3 XSlope (%)	N/A	N/A	Gutter 3 XSlope (%)	N/A
N/A	Painted X Walk3?	N/A	N/A	DWS 3 Provided?	N/A
N/A	X Walk 3 Direction	N/A	N/A	DWS 3 Contrast?	N/A
N/A	X Walk 3 Width (in)	N/A	N/A	DWS 3 Length (in)	N/A
N/A	Road 3 Slope (%)	N/A	N/A	DWS 3 Full Width?	N/A
N/A	Road 3 XSlope (%)	N/A	N/A	DWS 3 Offset (in)	N/A
Yes	Any Obstructions?	No	N/A	Storm Grate/Utility Hazard?	No
N/A	Obstruction Type		N/A	Storm Grate/Utility Type	
		N/A			N/A
N/A	Surface Condition	Good

Remove & Replace Detectable Warning System.
