Access Compliance Report

Public Rights-of-Way

(Island Curb Cuts)

Intersection ID: 10033070	Main Street: NORTH_COMMUNITY_HOUSE_RD	Cross Street: N/A	Location: S
ADA ID: 8CE2D44951D2	Curb Cut Type: MedianRefuge2	Initial Pass/Fail: Fail	Overall Compliance: No
Codes/Mitigation Info/Possible Solution		Field Measurements/Component Compliance

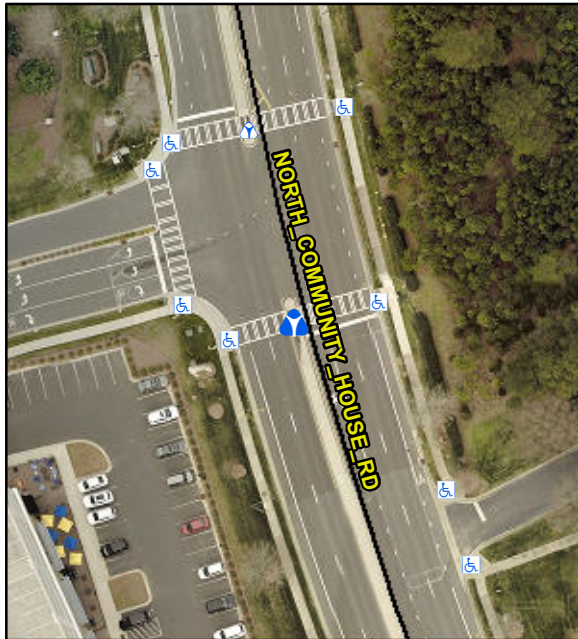
Compliance	Description	Data	Compliance	Description	Data
No	Refuge 1 Length (In)	33.5	N/A	Gutter 1 Ponding?	N/A
Yes	Refuge 1 Width (In)	120.0	N/A	Gutter 1 Lip Ht (In)	N/A
No	Refuge 1 Slope (%)	6.6	N/A	Gutter 1 Slope (%)	N/A
Yes	Refuge 1 X Slope (%)	1.3	N/A	Gutter 1 X Slope (%)	N/A
N/A	Painted X Walk1?	Yes	N/A	DWS 1 Provided?	N/A
N/A	X Walk 1 Direction	To E	N/A	DWS 1 Contrast?	N/A
N/A	X Walk 1 Width (In)	111.0	N/A	DWS 1 Length (In)	N/A
N/A	Road 1 Slope (%)	2.4	N/A	DWS 1 Full Width?	N/A
N/A	Road 1 X Slope (%)	7.5	N/A	DWS 1 Offset (In)	N/A
No	Refuge 2 Length (In)	33.5	N/A	Gutter 2 Ponding?	N/A
Yes	Refuge 2 Width (In)	120.0	N/A	Gutter 2 Lip Ht (In)	N/A
Yes	Refuge 2 Slope (%)	0.4	N/A	Gutter 2 Slope (%)	N/A
Yes	Refuge 2 X Slope (%)	1.7	N/A	Gutter 2 X Slope (%)	N/A
N/A	Painted X Walk2?	Yes	N/A	DWS 2 Provided?	N/A
N/A	X Walk 2 Direction	To W	N/A	DWS 2 Contrast?	N/A
N/A	X Walk 2 Width (In)	110.0	N/A	DWS 2 Length (In)	N/A

Remove & Replace Entire Refuge.

\$ 3000.00
