Access Compliance Report

Public Rights-of-Way

(Island Curb Cuts)

Intersection ID: 27942	Main Street: COMMUNITY HOUSE RD	Cross Street: NORTH COMMUNITY HOUSE RD	Location: SE
ADA ID: 8E5C639F58AE	Curb Cut Type: MedianRefuge2	Initial Pass/Fail: Fail	Overall Compliance: No
Severity Score: 12.5			
Codes/Mitigation Info/Possible Solution		Field Measurements/Component Compliance

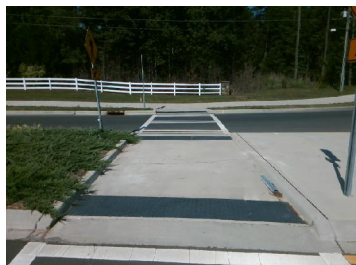
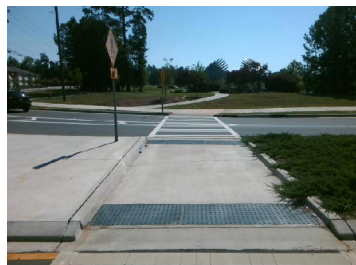
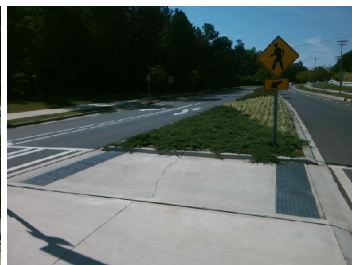
Compliance	Description	Data	Compliance	Description	Data
Yes	Refuge 1 Length (In)	109.0	N/A	Gutter 1 Ponding?	N/A
Yes	Refuge 1 Width (In)	118.0	N/A	Gutter 1 Lip Ht (In)	N/A
Yes	Refuge 1 Slope (%)	1.4	N/A	Gutter 1 Slope (%)	N/A
No	Refuge 1 X Slope (%)	5.1	N/A	Gutter 1 X Slope (%)	N/A
N/A	Painted X Walk1?	Yes	N/A	DWS 1 Provided?	N/A
N/A	X Walk 1 Direction	To SW	N/A	DWS 1 Contrast?	N/A
N/A	X Walk 1 Width (In)	109.0	N/A	DWS 1 Length (In)	N/A
N/A	Road 1 Slope (%)	1.1	N/A	DWS 1 Full Width?	N/A
N/A	Road 1 X Slope (%)	1.3	N/A	DWS 1 Offset (In)	N/A
Yes	Refuge 2 Length (In)	109.0	N/A	Gutter 2 Ponding?	N/A
Yes	Refuge 2 Width (In)	118.0	N/A	Gutter 2 Lip Ht (In)	N/A
Yes	Refuge 2 Slope (%)	1.5	N/A	Gutter 2 Slope (%)	N/A
Yes	Refuge 2 X Slope (%)	0.8	N/A	Gutter 2 X Slope (%)	N/A
N/A	Painted X Walk2?	Yes	N/A	DWS 2 Provided?	N/A
N/A	X Walk 2 Direction	To NE	N/A	DWS 2 Contrast?	N/A
N/A	X Walk 2 Width (In)	111.0	N/A	DWS 2 Length (In)	N/A

Remove & Replace Entire Refuge.
