Access Compliance Report

Public Rights-of-Way

(Island Curb Cuts)

Intersection ID: 17169	Main Street: IDLEWILD_RD	Cross Street: CEDARS_EAST_CT	Location: NW
ADA ID: 8E6FD563147A	Curb Cut Type: MedianRefuge2	Initial Pass/Fail: Fail	Overall Compliance: No
Severity Score: 1.25			
Codes/Mitigation Info/Possible Solution		Field Measurements/Component Compliance

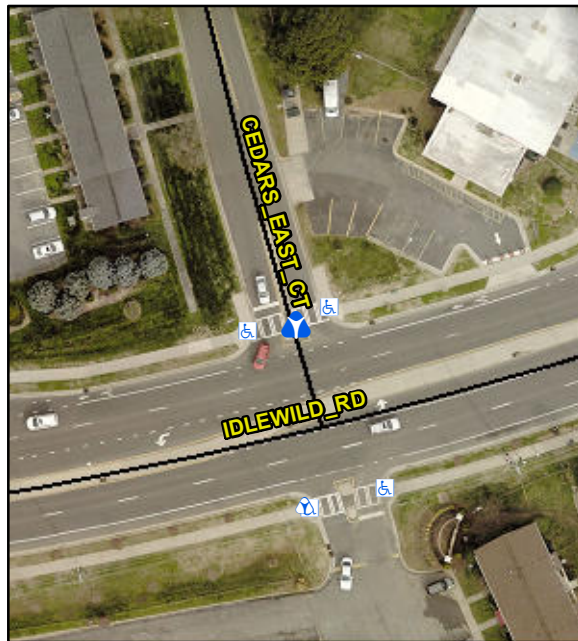
Compliance	Description	Data	Compliance	Description	Data
No	Refuge 1 Length (In)	22.0	N/A	Gutter 1 Ponding?	N/A
Yes	Refuge 1 Width (In)	120.0	N/A	Gutter 1 Lip Ht (In)	N/A
Yes	Refuge 1 Slope (%)	3.7	N/A	Gutter 1 Slope (%)	N/A
Yes	Refuge 1 X Slope (%)	4.0	N/A	Gutter 1 X Slope (%)	N/A
N/A	Painted X Walk1?	Yes	N/A	DWS 1 Provided?	N/A
N/A	X Walk 1 Direction	To SW	N/A	DWS 1 Contrast?	N/A
N/A	X Walk 1 Width (In)	111.0	N/A	DWS 1 Length (In)	N/A
N/A	Road 1 Slope (%)	3.5	N/A	DWS 1 Full Width?	N/A
N/A	Road 1 X Slope (%)	3.5	N/A	DWS 1 Offset (In)	N/A
No	Refuge 2 Length (In)	22.0	N/A	Gutter 2 Ponding?	N/A
Yes	Refuge 2 Width (In)	120.0	N/A	Gutter 2 Lip Ht (In)	N/A
Yes	Refuge 2 Slope (%)	0.3	N/A	Gutter 2 Slope (%)	N/A
Yes	Refuge 2 X Slope (%)	3.2	N/A	Gutter 2 X Slope (%)	N/A
N/A	Painted X Walk2?	Yes	N/A	DWS 2 Provided?	N/A
N/A	X Walk 2 Direction	To NE	N/A	DWS 2 Contrast?	N/A
N/A	X Walk 2 Width (In)	110.0	N/A	DWS 2 Length (In)	N/A

Remove & Replace Entire Refuge.
