Access Compliance Report

Public Rights-of-Way

(Island Curb Cuts)

Intersection ID: 48492	Main Street: SHOPTON_RD_WEST	Cross Street: BEREWICK_COMMONS_PY	Location: SE
ADA ID: 8F3F55CA628D	Curb Cut Type: MedianRefuge2	Initial Pass/Fail: Fail	Overall Compliance: No
Codes/Mitigation Info/Possible Solution		Field Measurements/Component Compliance	
Severity Score: 0

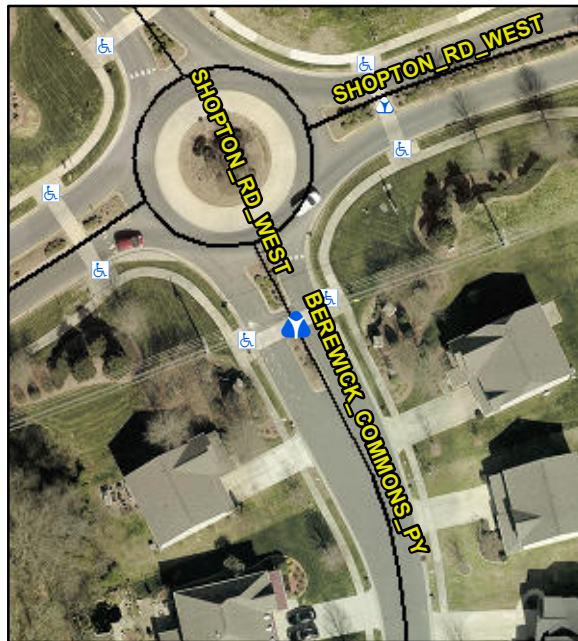
Compliance	Description	Data	Compliance	Description	Data
Yes	Refuge 1 Length (In)	65.0	N/A	Gutter 1 Ponding?	N/A
Yes	Refuge 1 Width (In)	169.0	N/A	Gutter 1 Lip Ht (In)	N/A
Yes	Refuge 1 Slope (%)	0.1	N/A	Gutter 1 Slope (%)	N/A
Yes	Refuge 1 X Slope (%)	2.6	N/A	Gutter 1 X Slope (%)	N/A
N/A	Painted X Walk1?	Yes	N/A	DWS 1 Provided?	N/A
N/A	X Walk 1 Direction	To NE	N/A	DWS 1 Contrast?	N/A
N/A	X Walk 1 Width (In)	96.0	N/A	DWS 1 Length (In)	N/A
N/A	Road 1 Slope (%)	2.5	N/A	DWS 1 Full Width?	N/A
N/A	Road 1 X Slope (%)	2.5	N/A	DWS 1 Offset (In)	N/A
Yes	Refuge 2 Length (In)	65.0	N/A	Gutter 2 Ponding?	N/A
Yes	Refuge 2 Width (In)	169.0	N/A	Gutter 2 Lip Ht (In)	N/A
Yes	Refuge 2 Slope (%)	1.4	N/A	Gutter 2 Slope (%)	N/A
Yes	Refuge 2 X Slope (%)	0.8	N/A	Gutter 2 X Slope (%)	N/A
N/A	Painted X Walk2?	Yes	N/A	DWS 2 Provided?	N/A
N/A	X Walk 2 Direction	To SW	N/A	DWS 2 Contrast?	N/A
N/A	X Walk 2 Width (In)	96.0	N/A	DWS 2 Length (In)	N/A

N/A	Road 2 Slope (%)	2.5	N/A	DWS 2 Full Width?	N/A
N/A	Road 2 X Slope (%)	0.6	N/A	DWS 2 Offset (In)	N/A
N/A	Refuge 3 Length (in)	N/A	N/A	Gutter 3 Ponding?	N/A
N/A	Refuge 3 Width (in)	N/A	N/A	Gutter 3 Lip Ht (in)	N/A
N/A	Refuge 3 Slope (%)	N/A	N/A	Gutter 3 Slope (%)	N/A
N/A	Refuge 3 XSlope (%)	N/A	N/A	Gutter 3 XSlope (%)	N/A
N/A	Painted X Walk3?	N/A	N/A	DWS 3 Provided?	N/A
N/A	X Walk 3 Direction	N/A	N/A	DWS 3 Contrast?	N/A
N/A	X Walk 3 Width (in)	N/A	N/A	DWS 3 Length (in)	N/A
N/A	Road 3 Slope (%)	N/A	N/A	DWS 3 Full Width?	N/A
N/A	Road 3 XSlope (%)	N/A	N/A	DWS 3 Offset (in)	N/A
Yes	Any Obstructions?	N/A	N/A	Storm Grate/Utility Hazard?	N/A
N/A	Obstruction Type		N/A	Storm Grate/Utility Type	
		N/A			N/A
N/A	Surface Condition	Good

Remove & Replace Entire Refuge.
